Lincoln Park

Landscape Rehabilitation Plan

Portland, Maine

Prepared by: Mohr & Seredin, Landscape Architects, Inc.
Prepared for: City of Portland, Maine
Friends of Lincoln Park
December, 2014

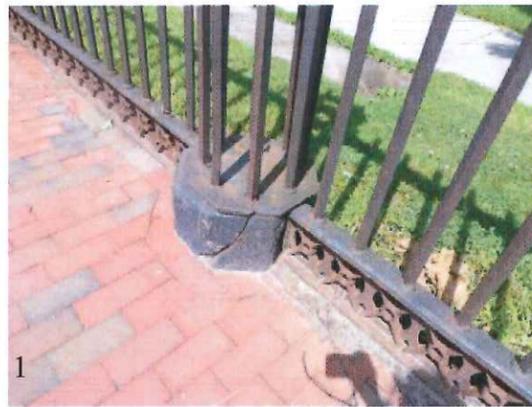
1

New brick sidewalk is constructed too high underneath fence which is accelerating deterioration.

Fence needs restoration. Brick sidewalk too high along southern edge

Restore fence, pillars, gates and bollards.
Correct grade relationship at base of fence to keep moisture from deteriorating fence.

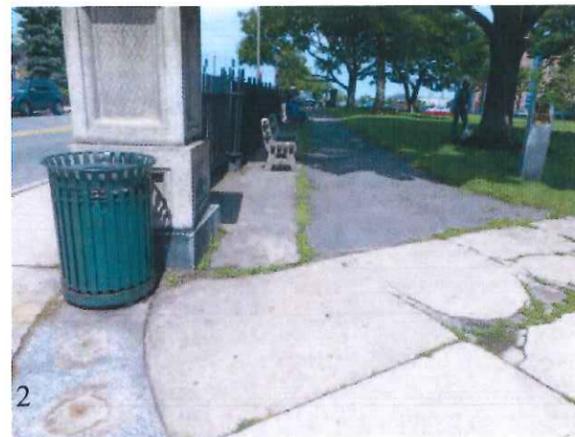
2

- d. Trash Receptacles: The present receptacles are now sited at the entrance to the park adjacent to the entry posts, they are green with a flair at the top, They detract from the character of the entry and are not in keeping with the character of the park. (*Exhibit E: photo 2*)

Trash can detracts from park entry

6. **Trash Receptacles:** The selection of a suitable trash receptacle should be made so that the receptacle is compliant with the City standards. The trash receptacles need to be carefully placed so that they do not conflict or compete with the key park features (entry pillars, the fountain). They should be located on the sidewalk adjacent to the Park entrance or inside the Park. The trash receptacles should be black to minimize their visual impact, and to be compatible with the black iron of the fence and benches. Recommended trash receptacle is shown in the attached *Exhibit H*.

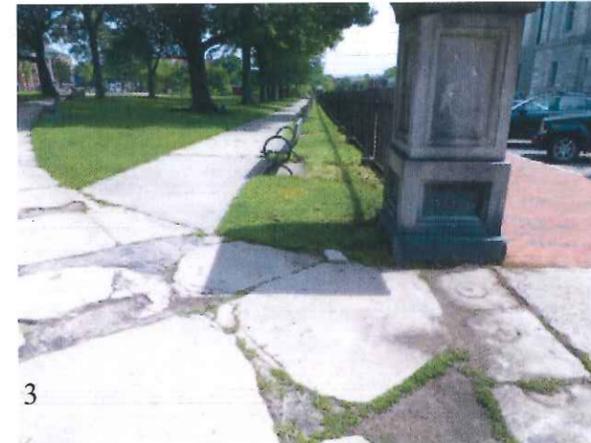
3

Deteriorated pavement

The existing walks within the Park are in very poor condition and will require full depth reconstruction. As one of the most important character defining features of Lincoln Park, the walks should be replaced with new concrete walks constructed to the City's Standards, but must exactly replicate the widths, alignment, and joint pattern of the historic sections of the existing walkways in the Park. Care should be taken to match the color of the existing concrete walks so that the new cement is not too "white". Concrete

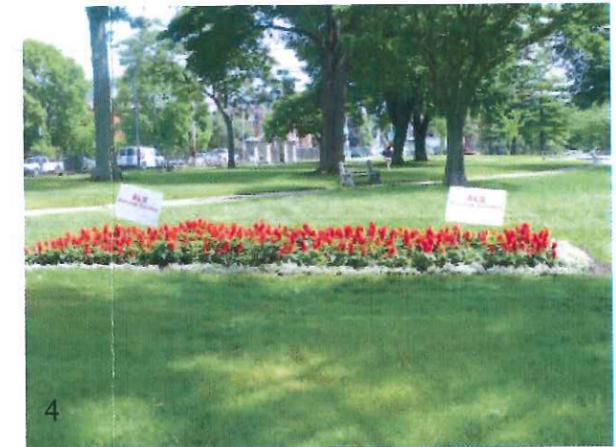
4

Only one herbaceous plant bed is planted and contains two large plastic white signs

Unattractive signs in flower bed

- c. **Signage:** The City should develop a policy limiting both temporary and permanent signage at Lincoln Park. We recommend that no additional permanent signs be added inside the Park or on the Park entrances, except for a discrete (4" by 6") plaque noting the fountain restoration information. Temporary signs need to be carefully controlled for size and location. Given the open character of the Park, single, temporary signs should be limited in size (maximum 6" by 12") with subdued colors, and located only in limited areas where needed (eg. in the herbaceous beds). (*Exhibit J*)

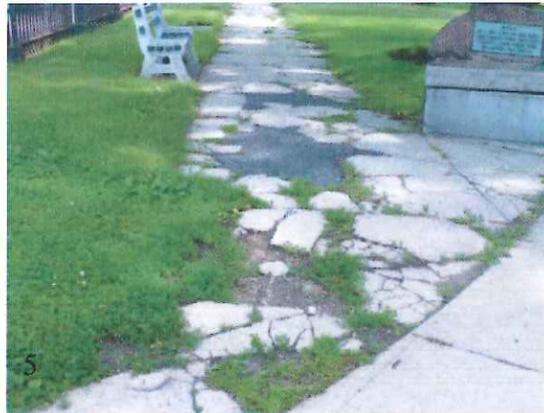
5

Deteriorated pavement at Northeast corner

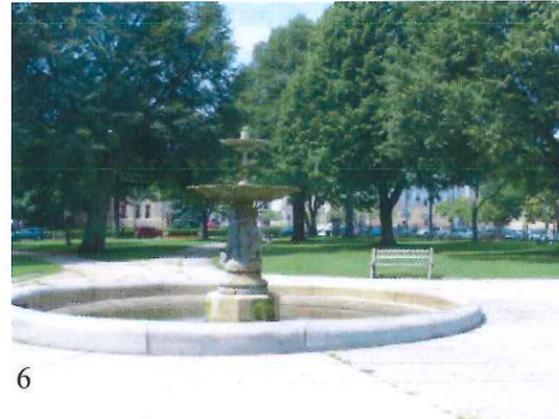
6

- b. Fountain: The fountain structure is in poor condition, but has a high degree of integrity with the exception of the missing top tier, and the intermittent use as an active water feature. The fountain is no longer operational, so does not serve to animate the Park and draw activity into the Park. (*Exhibit E: photo 6*)

The existing fountain and water basin should be professionally restored by a mason, and the top tier replaced using the historic photographs to create the replacement portions of the fountain. The restoration needs to include the required plumbing repairs so that the fountain is a functioning water feature. As a part of this work, the City of Portland should consider allowing the use of the water basin by the public for wading and cooling in the summer months. This policy decision will inform the determination on how to design the plumbing for the fountain in terms of either a pumped recirculation system versus direct flow and drainage into the City sewer system.

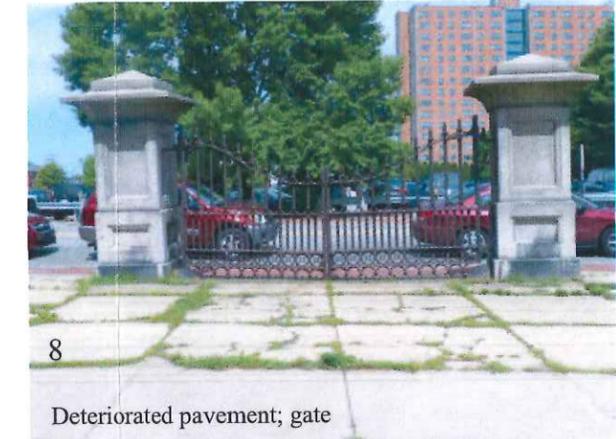
8

Deteriorated pavement; gate

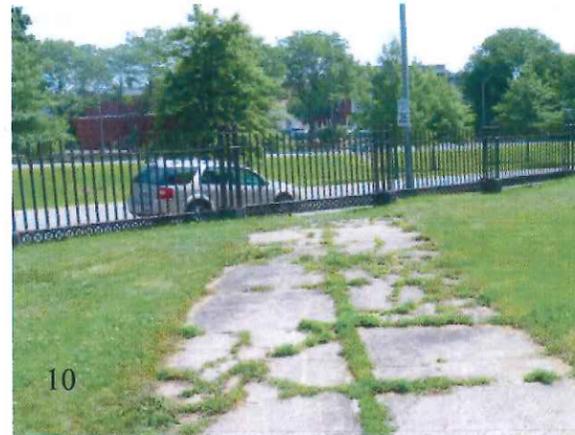
10

When the park was reduced in size, the eastern walks were truncated and the perimeter circulation was never replaced along Franklin Street. The result is that the symmetrical circulation pattern was changed, and the curving diagonal walks leading toward Munjoy Hill are cut off and dead end at the fence.

Truncated walk

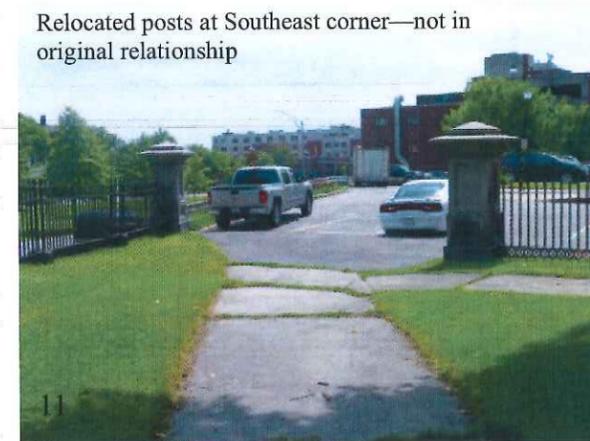
11

Relocated posts at Southeast corner—not in original relationship

- i. Fence and pillar layout along eastern edge to be restored to original corner relationship regardless of the outcome of the Franklin Arterial study.

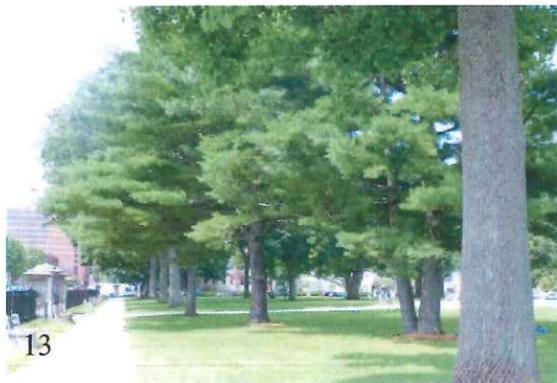
13

5. Vegetation: The tree canopy is quite fragmented and the tree species are varied based upon sequential planting over the past thirty to forty years. This feature has lost most of its integrity, and the park character is diminished due to this change. *(Exhibit E: photos 7,9,13,14)*

Pine trees in Southeast corner

- a. Tree Plantings: Existing trees should be retained, and maintained, and removed only as necessary due to health, vigor, or natural decline. New trees should be planted in a pattern to re-establish a continuous canopy within the park; along walkways and at the perimeter of the Park. The trees currently within the lawn panels should not be replaced after they have been removed. To achieve a character similar to the historic tree canopy while accommodating the City's tree planting policies, the new tree plantings shall be a mixture of disease resistant Elm Cultivars (Valley Forge, Accolade, Independence, Regal, New Horizon, Patriot). Evergreens are not an appropriate tree selection.

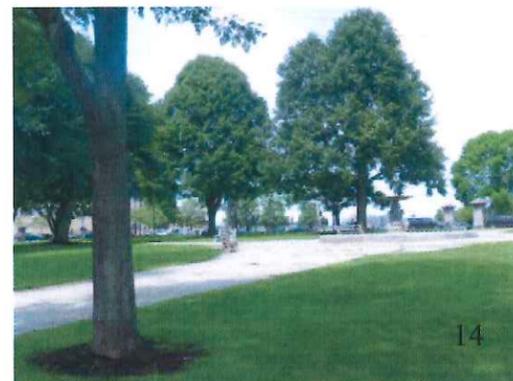
14

Fountain area: no tree canopy, few benches, deteriorated

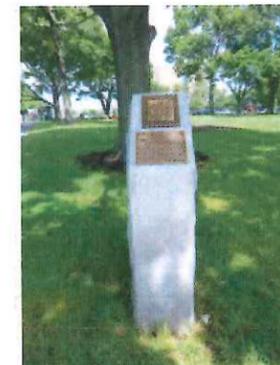
15

Recently added monument at Northwest entry

7. **Monuments/Memorials:** The City should adopt a policy that does not permit the introduction of any additional monuments or memorials within the Park. This will assure that the simple, uncluttered character of the Park is preserved in a manner consistent with the historic design intent. The existing stone monument with the brass inscription plate should be relocated to a prominent, but less focal position, such as the northeastern Park corner near the northern Federal Street entrance.

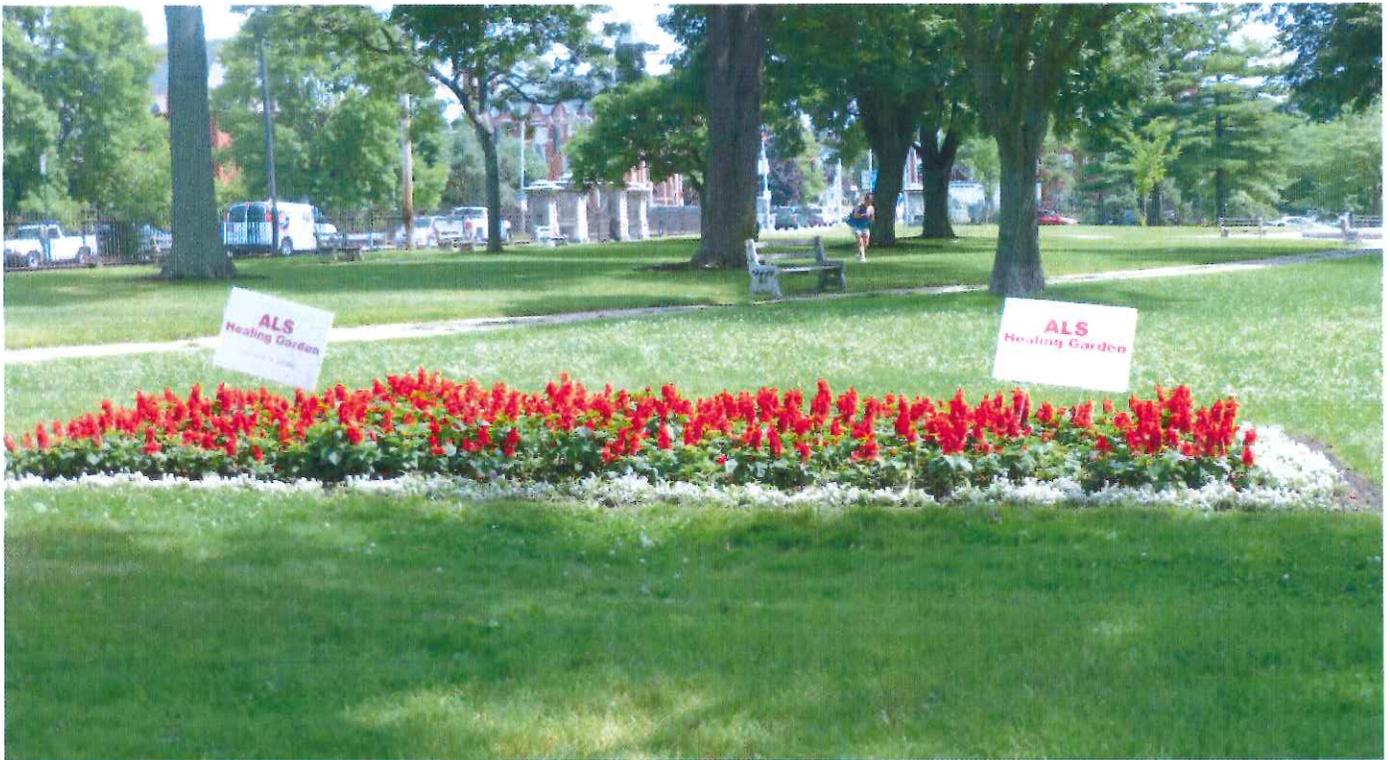
Summer 2014 Temporary Signage -
Too large and detracts from plantings

Recommended Temporary Signage -
Smaller and lower sign, use one per plant bed.
