## **Merrill Street**

### ***Architectural Character of the Street***

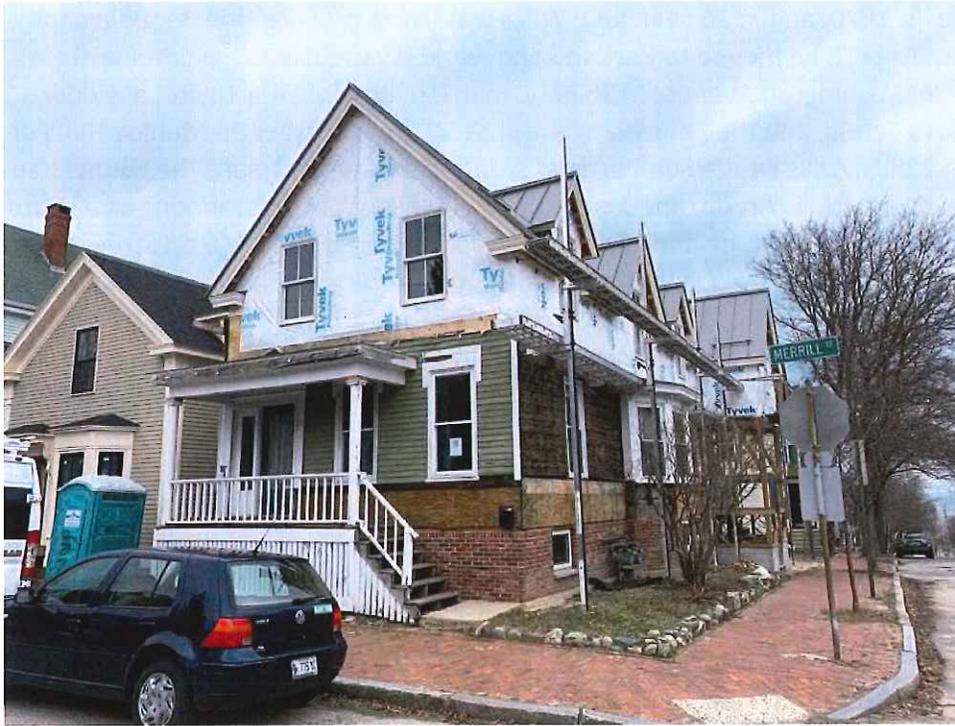
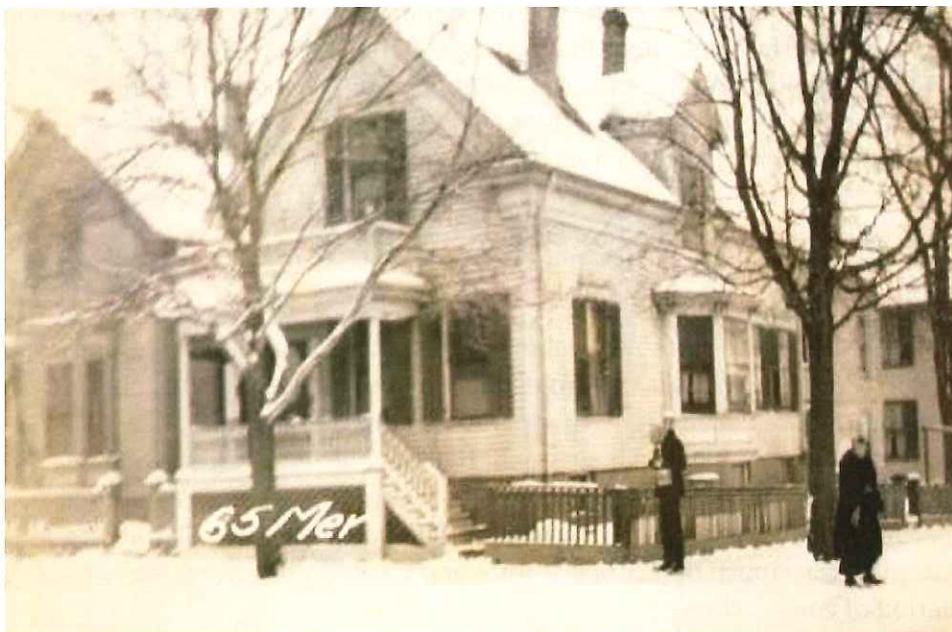
**Address:** 65 Merrill Street

The front-gabled, one-and-a-half-story dwelling is largely vernacular in style, with Greek Revival influences. At the time of the assessment, the structure was undergoing several alterations, including the addition of dormers, windows, new siding, and a projected gable bay at the building's rear. The dwelling's distinguishing characteristics are an asymmetrical façade with partial covered entry porch, a canted bay window, and wall dormers over the eastern elevation.

Since 1924, 65 Merrill Street has received several alterations. Significant additions include two of the eastern elevation's dormer windows and projecting bay. The façade's single gable window has been removed and replaced with two separate windows. Although the dwelling's updates are not complete, at the time of the assessment the original wide friezes, window crowns, and shutters have been removed. The front porch's second-story balustrade has also been removed, and a lattice foundation has been replaced with vertical panels. Despite its alterations, the house maintains much of its original form and larger architectural features, which speak to its period of construction.

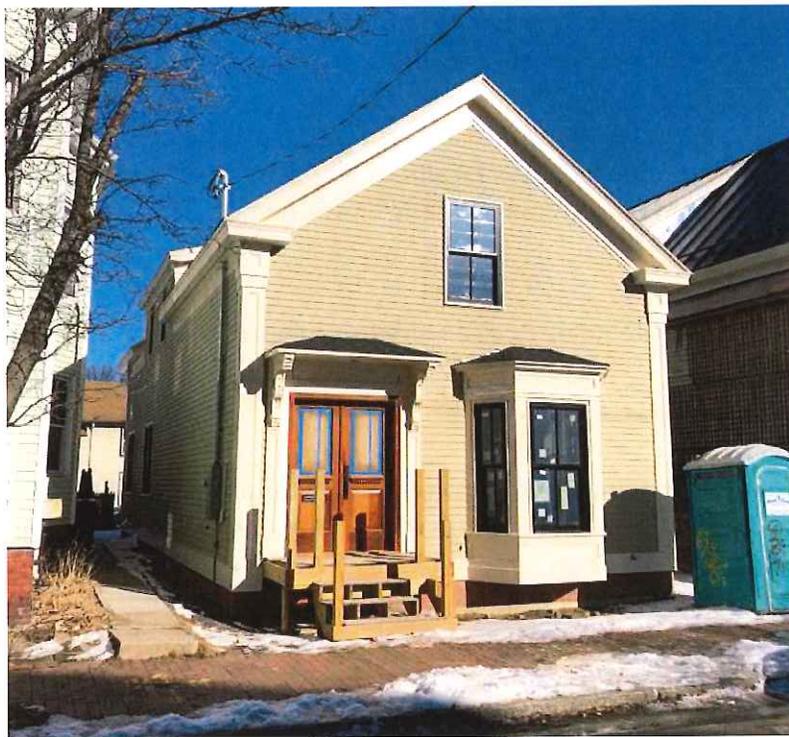
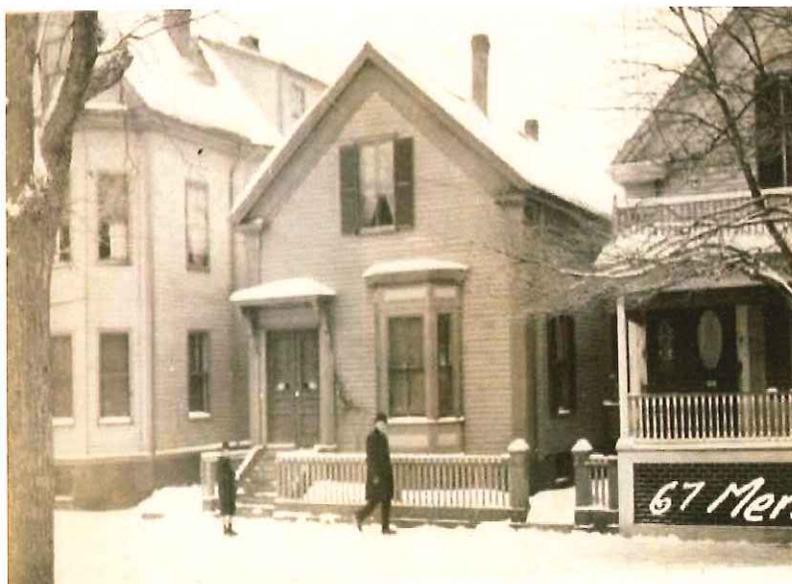
**Address:** 67 Merrill Street  
**Approximate/Documented Date of Building:** 1866-1867  
**Surveyed:** 8/17/2018  
**Historic Name:** John M. Stevens House  
**Contributing or Noncontributing:** Contributing

The one-and-a-half-story, single-family home has Italianate and Greek Revival influences. The property's distinguishing features include wide corner boards and eaves, eave returns, a canted bay window, and a large, bracketed hood over the main entry. The dwelling is two-by-two bays wide, and has recently replaced siding and repainted corner boards, friezes, and trim. The corner boards, main entry surround, and bay window trim all feature similar panel insets, which feel accentuated due to the small scale of the dwelling's façade. The house's wide friezes and corner boards, which support returning eaves, communicate the house's nineteenth-century origins.

67 Merrill Street has received multiple iterations of alterations to the exterior since 1924. At the time surveyed, the property was in the midst of receiving several updates, including new or restored windows, doors, siding, and trim. These updates reflect the house's historical character better than many of its previous updates. The new double-door entry and replacement 2/2 windows reflect the 1924 traits of the house. Previously, the house had been updated with a single main entry door and 1/1 windows, and the trim and siding were in poor condition. The house's corner boards, frieze, bay window, and double-door entry with bracketed hood all contribute to its historical character and that of Munjoy Hill.

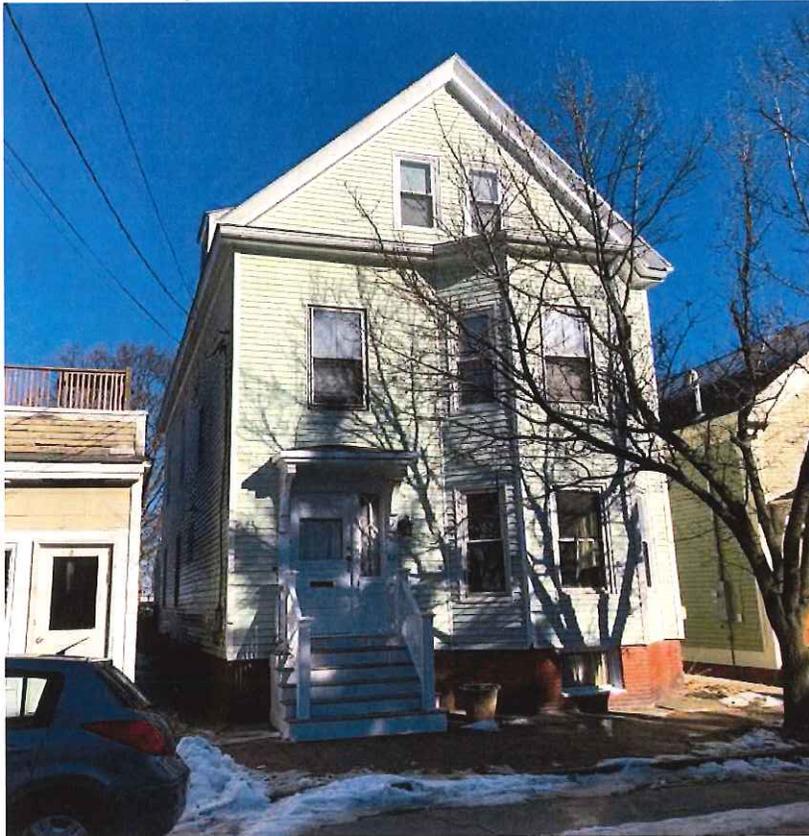
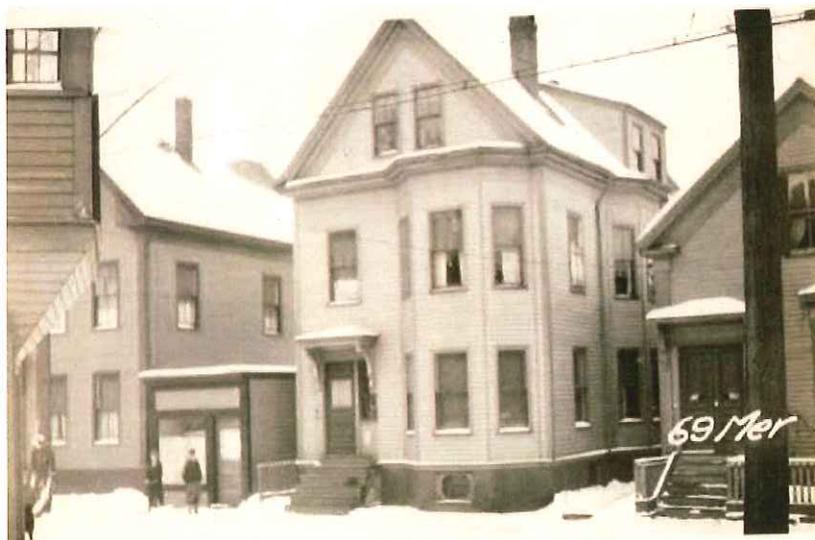
**Address:** 69 Merrill Street

69 Merrill Street is a good example of a front-gable home built on one of the narrow lots that typify Munjoy Hill's historic character. The two-and-a-half-story vernacular home has Italianate features, including a bracketed hood over the main entry, and two-story canted bay windows on the façade and side elevation. The house's most stylized element is the main entry, which boasts the bracketed hood, mullion sidelight, and the original door with a single light over panel insets.

The updates 69 Merrill Street has received since 1924 have not drastically altered its appearance. Aside from replacement vinyl siding and the loss of several original windows and a frieze below the gable, the house has retained its historical form and features. Otherwise, the house maintains its historical integrity and serves as an example of the turn-of-the-century development that took place on Munjoy Hill.

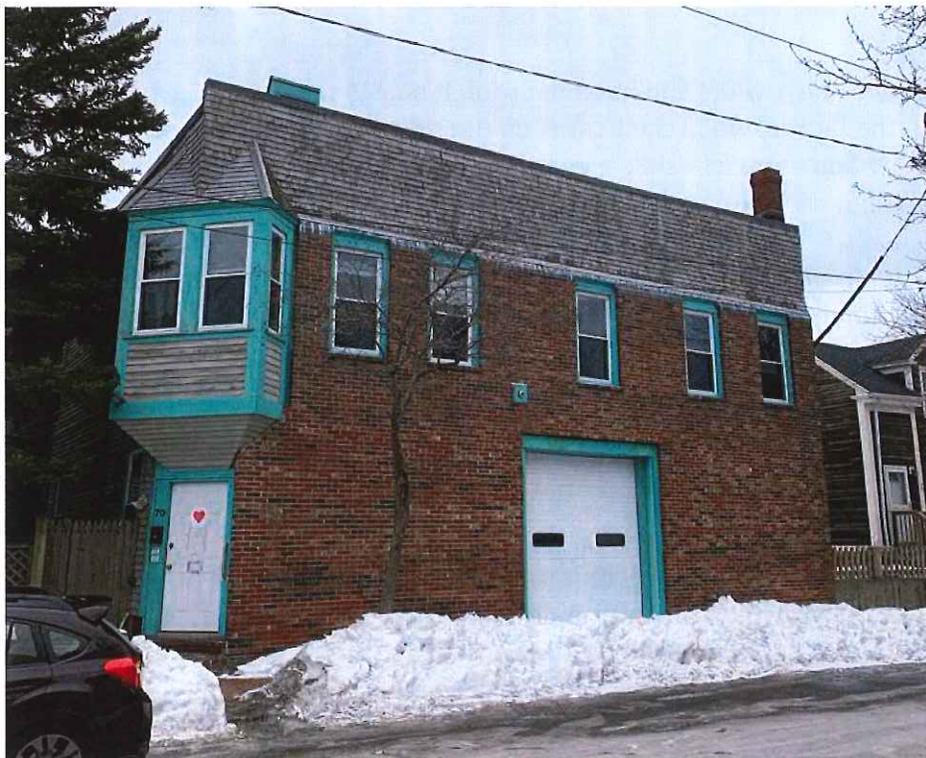
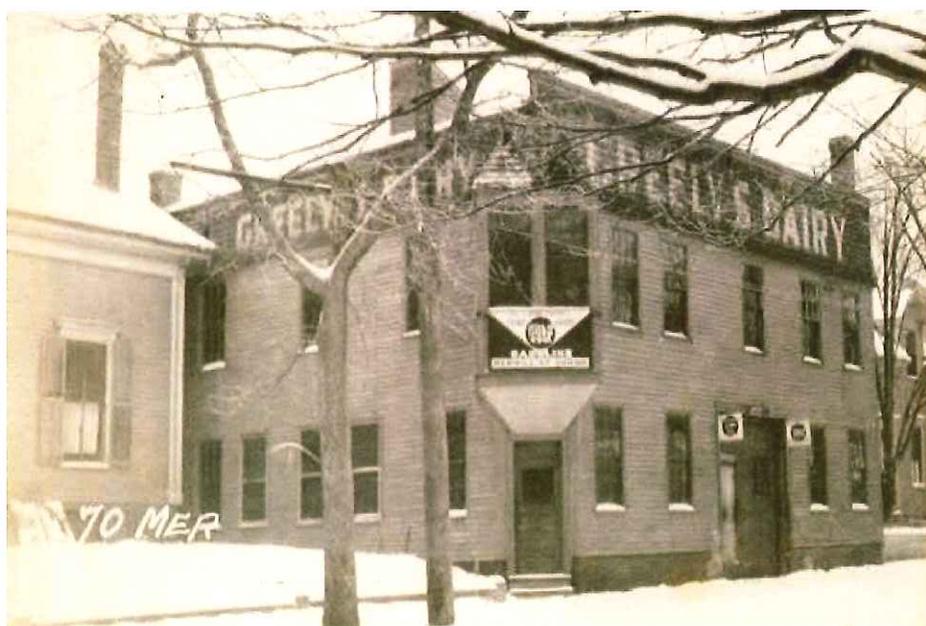
**Address:** 70 Merrill Street  
**Approximate/Documented Date of Building:** c. 1880  
**Surveyed:** 8/17/2018  
**Historic Name:** Greely's Dairy  
**Contributing or Noncontributing:** Contributing

The building is five by seven bays wide, and has a flat roof. It boasts several siding materials, including faux brick on the façade, wood clapboards on the side elevations, and cedar shingles above the second-level windows on all visible elevations. The building's replacement 1/1 vinyl sash windows have wooden trim with panel insets, above.

The most significant alteration to 70 Merrill Street since 1924 is the addition of brick siding on the façade. The windows, garage door, and main entry door have all been updated. However, the building's original use as a business is still plainly discernable, and its distinctive appearance contributes to the diverse historical architectural fabric of Munjoy Hill.

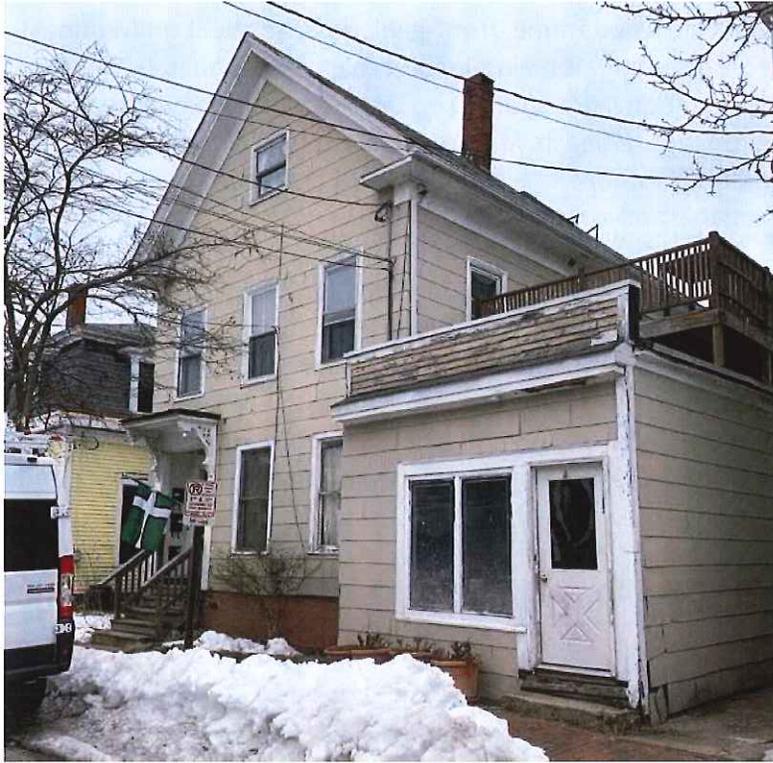
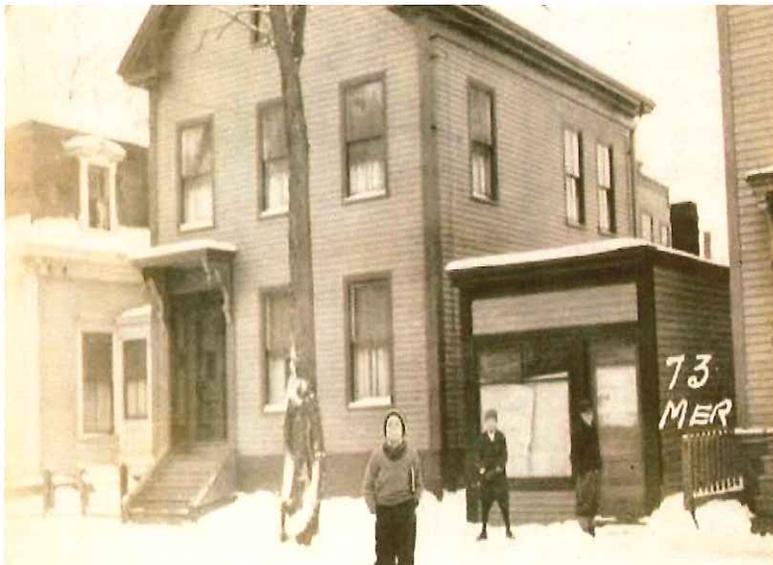
**Address:** 73 Merrill Street

The main structure is three bays wide by nine bays deep. The shop is an additional two bays wide. The house and shop are nestled tightly between neighboring dwellings, so the side elevations are not easily visible. The house has replacement siding, and the majority of the windows are replacement 1/1 vinyl sash, with a few 2/1 wooden sash. The recessed entry in the façade's first bay has panel insets on the interior walls and a hood that is supported by the original pierced brackets. The asphalt roof has one visible chimney on the eastern interior slope.

The most observable alterations to 73 Merrill Street since 1924 are the addition of a roof deck over the shop, and the loss of the wood clapboard siding and corner boards, which were fairly substantial on the one-story shop. Additional changes are the replacement of 2/2 windows and the altered main entry access steps. The shop once featured a large picture display window, rather than a window pair. While these changes slightly diminish the structure's nineteenth-century character, it still retains the larger elements that speak to its era of construction, and contributes to Munjoy Hill's eclectic residential and business history.
