Lincoln Park

Landscape Rehabilitation Plan

Portland, Maine

Prepared by: Mohr & Seredin, Landscape Architects, Inc.
Prepared for: City of Portland, Maine
Friends of Lincoln Park
December, 2014

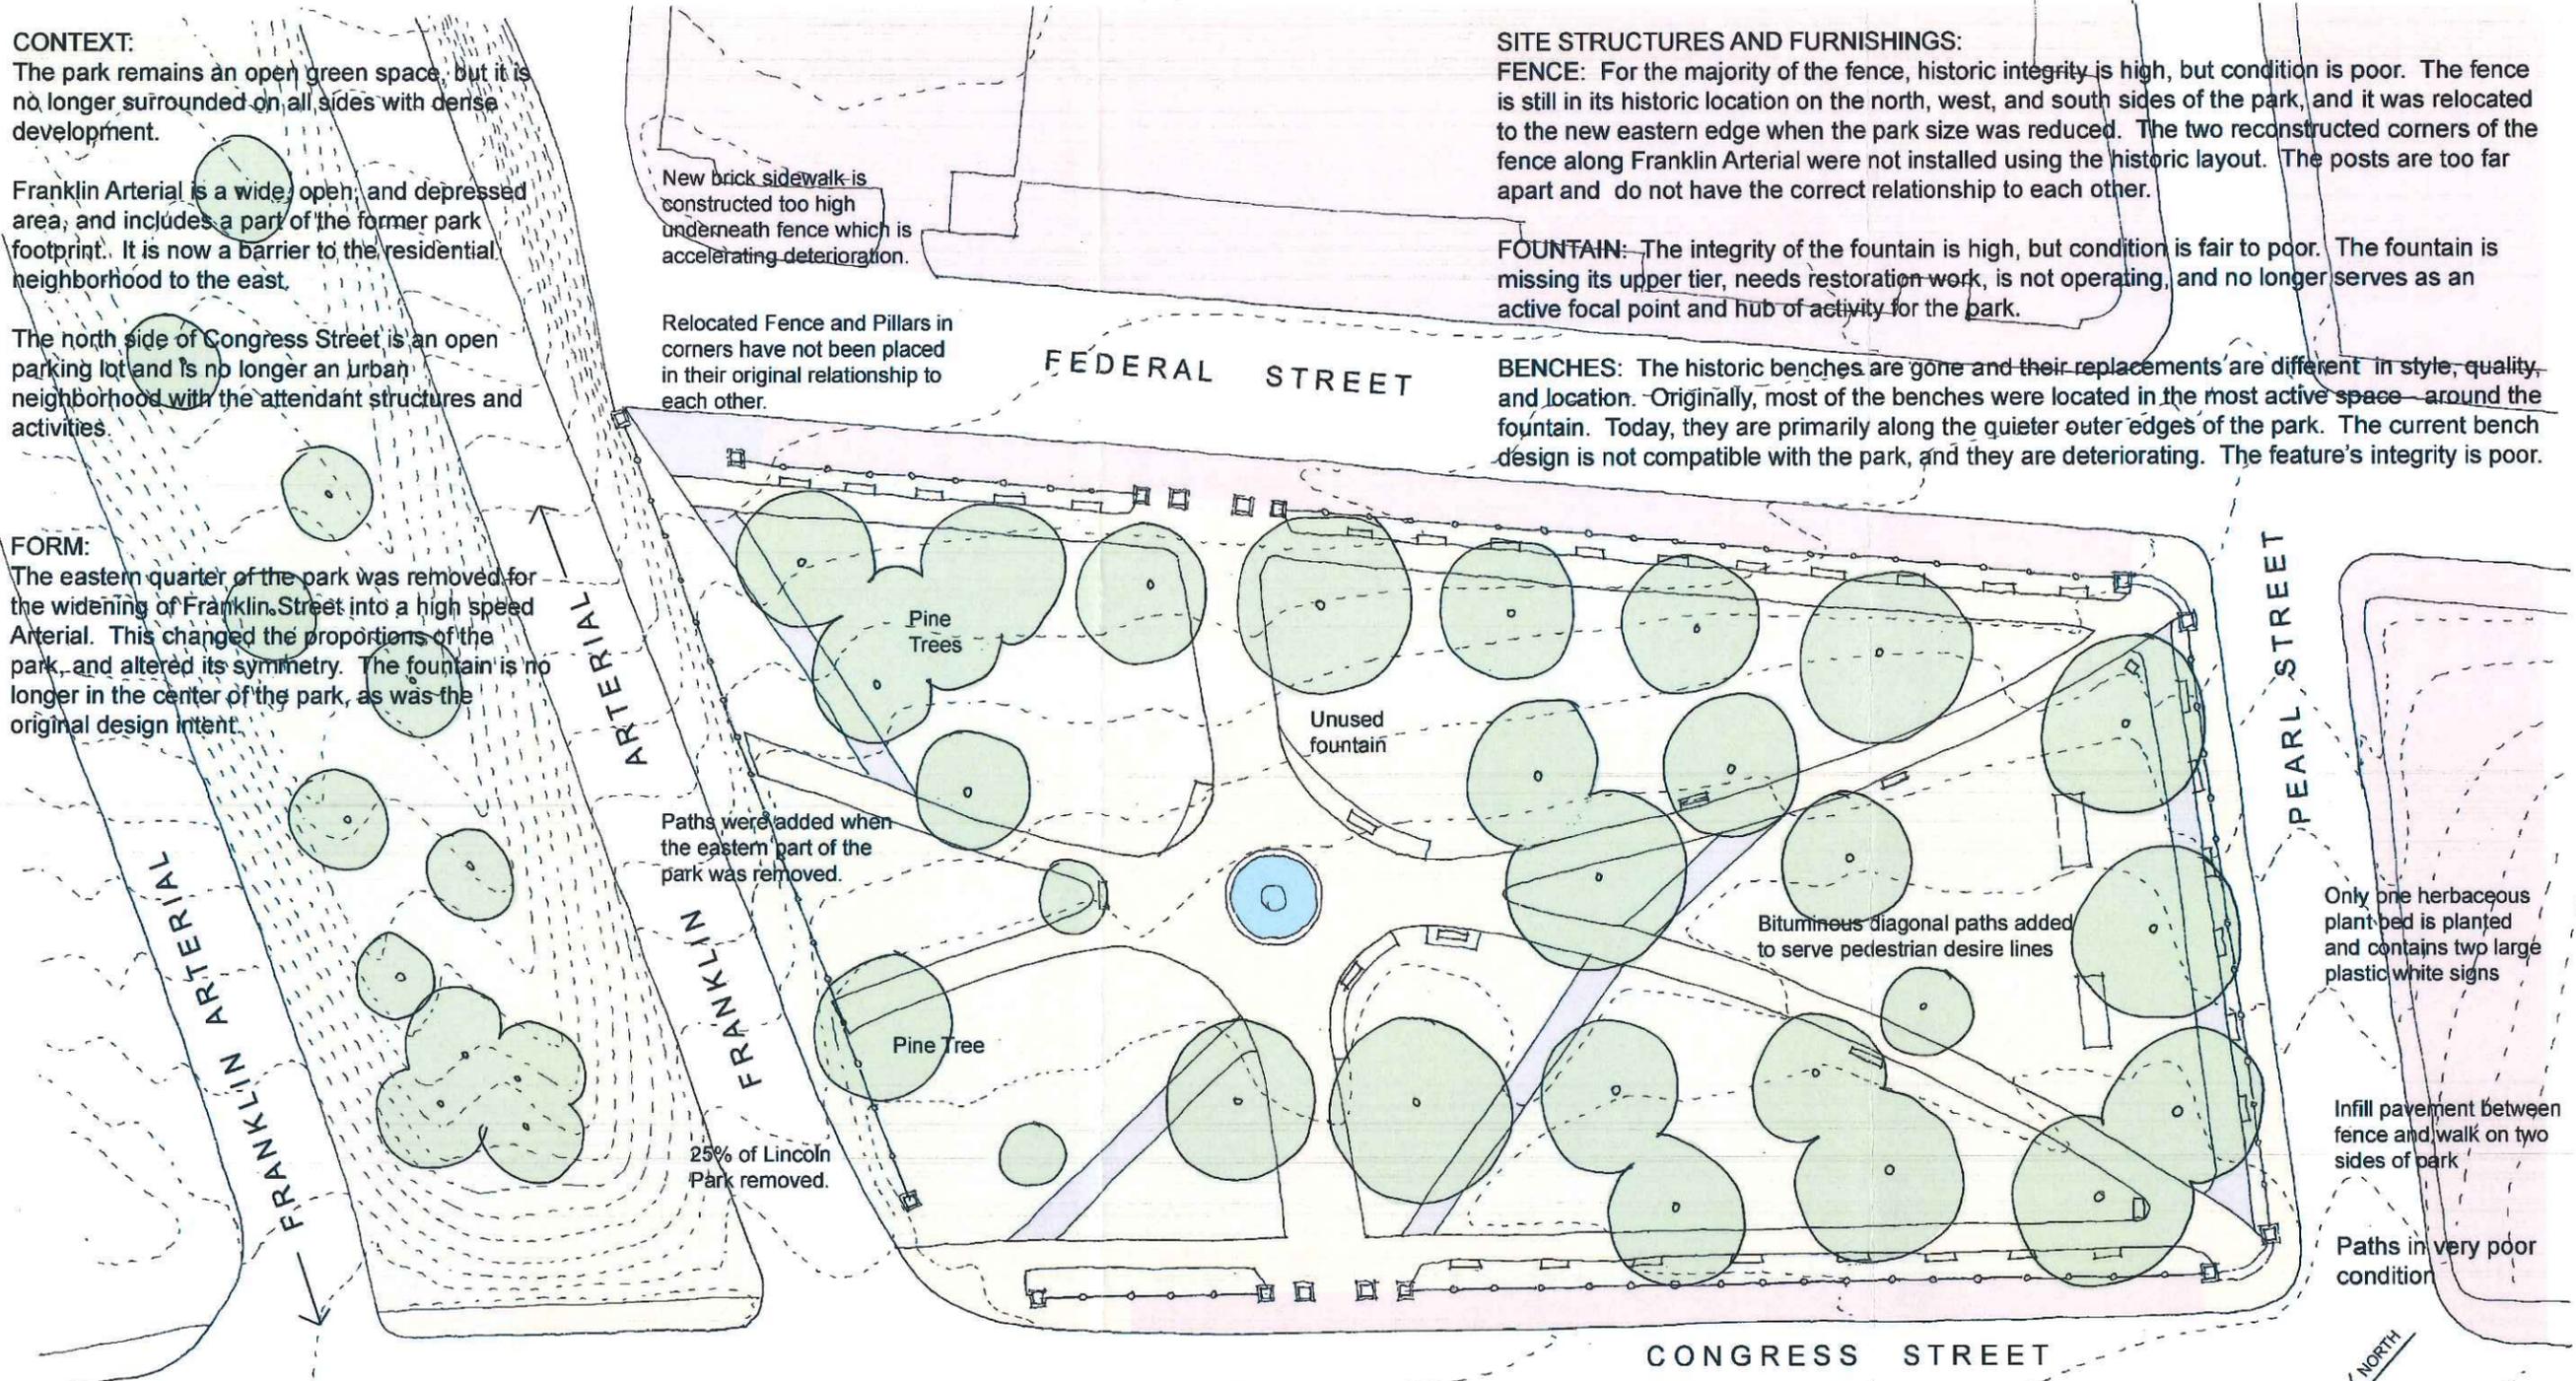
Only one herbaceous plant bed is planted and contains two large plastic white signs

Infill pavement between fence and walk on two sides of park

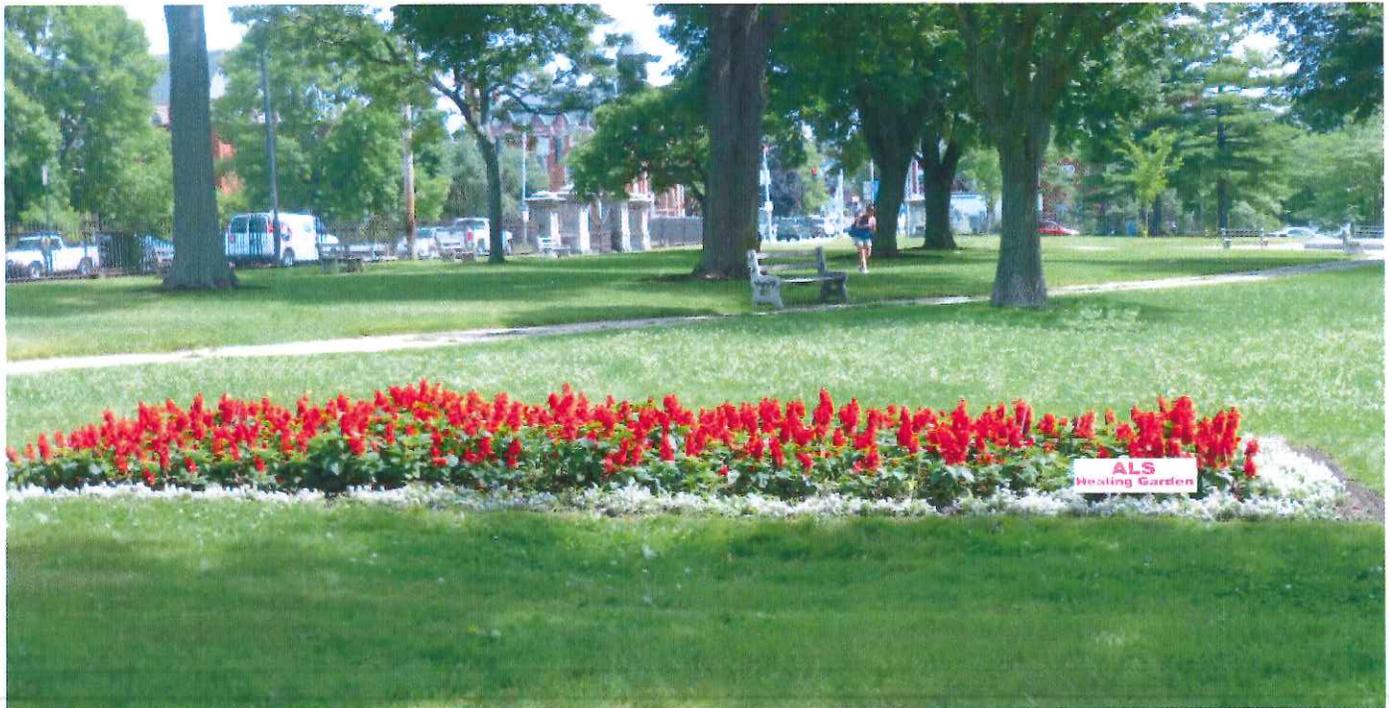
Temporary Signage
Recommendation

Summer 2014 Temporary Signage -
Too large and detracts from plantings

- c. **Signage:** The City should develop a policy limiting both temporary and permanent signage at Lincoln Park. We recommend that no additional permanent signs be added inside the Park or on the Park entrances, except for a discrete (4" by 6") plaque noting the fountain restoration information. Temporary signs need to be carefully controlled for size and location. Given the open character of the Park, single, temporary signs should be limited in size (maximum 6" by 12") with subdued colors, and located only in limited areas where needed (eg. in the herbaceous beds). (*Exhibit J*)

Recommended Temporary Signage -
Smaller and lower sign, use one per plant bed.
