# EASTERN PROMENADE MASTER PLAN - PORTLAND, MAINE -

PORTLAND DEPARTMENT OF PARKS AND RECREATION  
WALKER-KLUESING DESIGN GROUP

*Adopted as part of  
Portland's Comprehensive Plan  
by City Council on 17 November 2003*

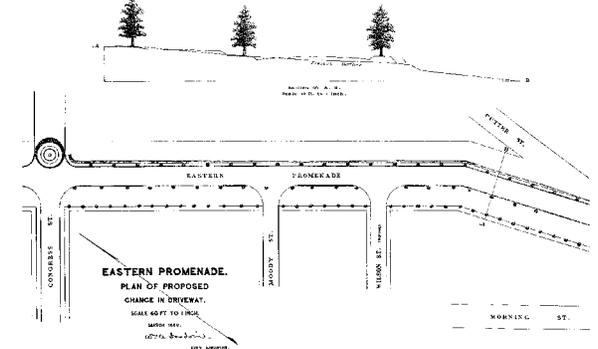
*Goodwin plan for Eastern Promenade, 1889*

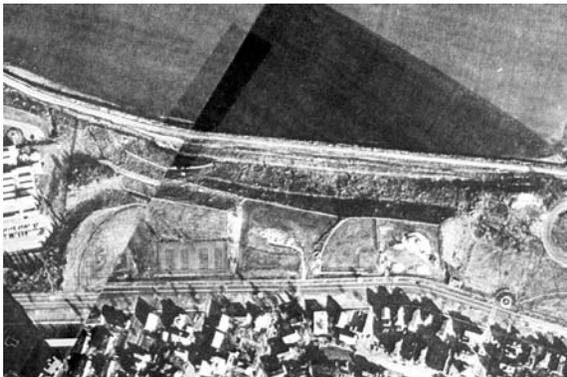
*Aerial photograph of Cutter Street landfill, 1979  
{Portland Dept. of Public Works}*

The Cutter Street landfill began in 1976 on the slope below the softball field and extended to Cutter Street. Completed in 1979, it was an engineered approach to shaping land that eliminated the soft landscape forms desired in a typical Olmsted park. Some are concerned that this landfill may contain contaminants. In 1991 DEP identified some areas not to be disturbed.

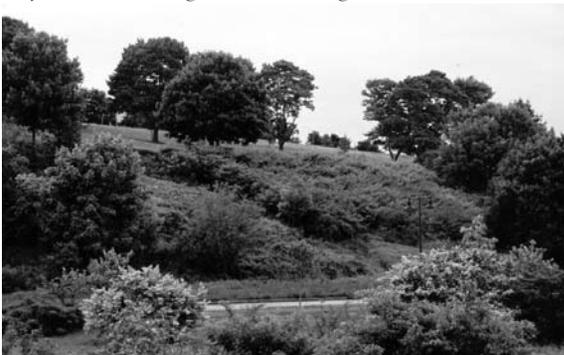
*Experiment in vegetation management, 2003*

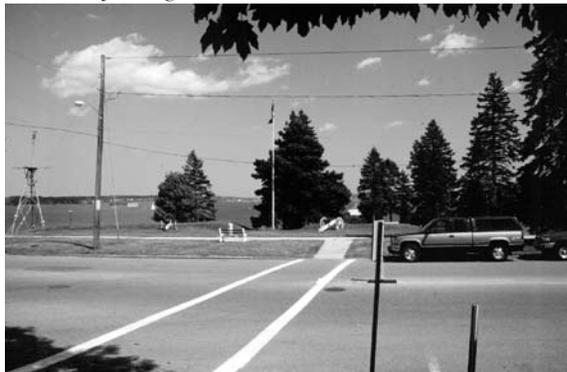
*Views to water at Fort Allen blocked by evergreen trees, 2003*

Plants in Fort Allen are primarily evergreen and include Chamaecyparis, Douglas Fir, Red Pine, Contorted Pine and Spruce as well as Junipers. The Firs have an aphid infestation. Fort Allen does not appear to be an appropriate historic location for evergreen trees. Deciduous plants include Norway Maple, Crabapple and Lilac.

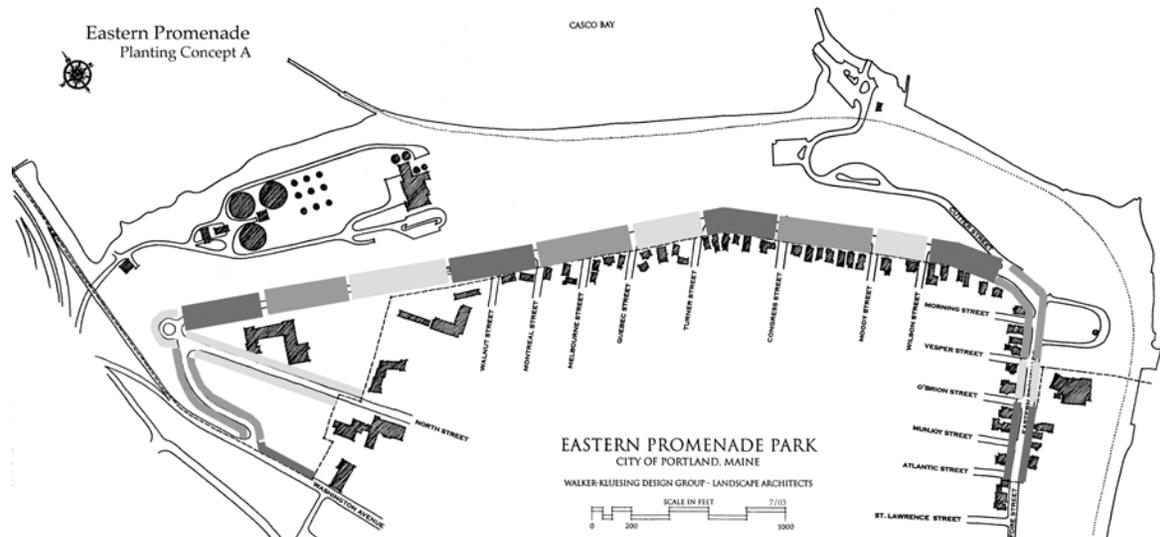
*Concept Planting Diagram for Eastern Promenade*

To achieve this aspect of the plan it is recommended that infill occur after a plan is developed and adopted. The next step is to remove and replace the Norway Maples as they have the most incompatible form and density relative to the historic experience. Other species can be removed and replaced after that to achieve the overall plan.

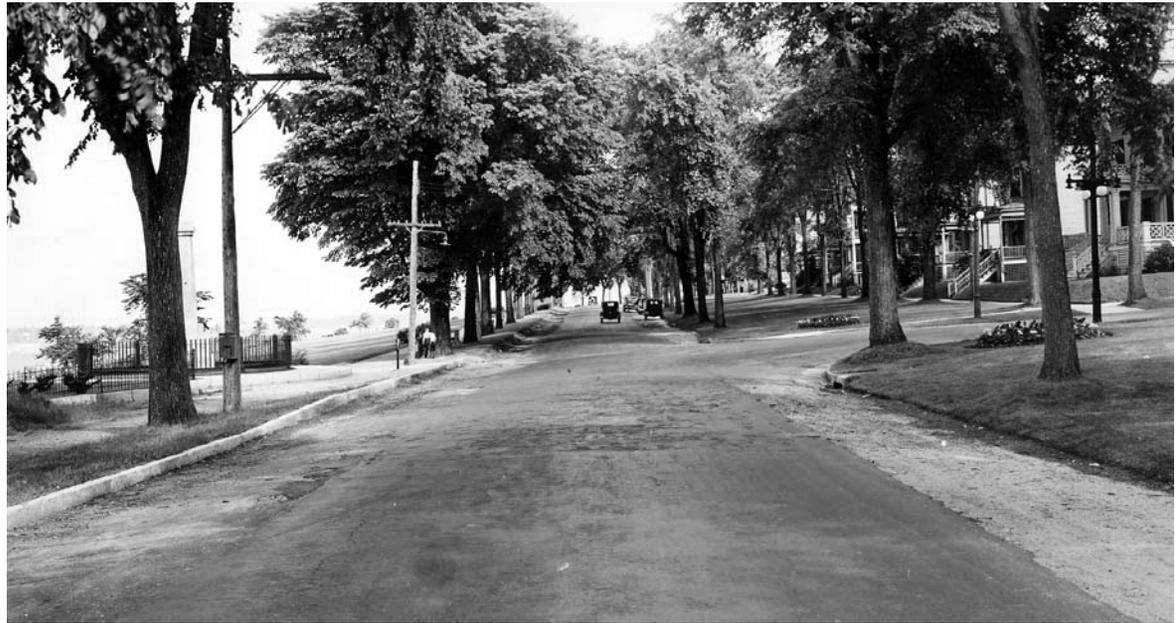
*Olmsted Brothers grading plan  
for the Northern Concourse, 1905  
[National Park Service,  
Frederick Law Olmsted National Historic Site]*

The Northern Concourse was built between 1905 and 1906 in general accordance with the Olmsted firm plan.

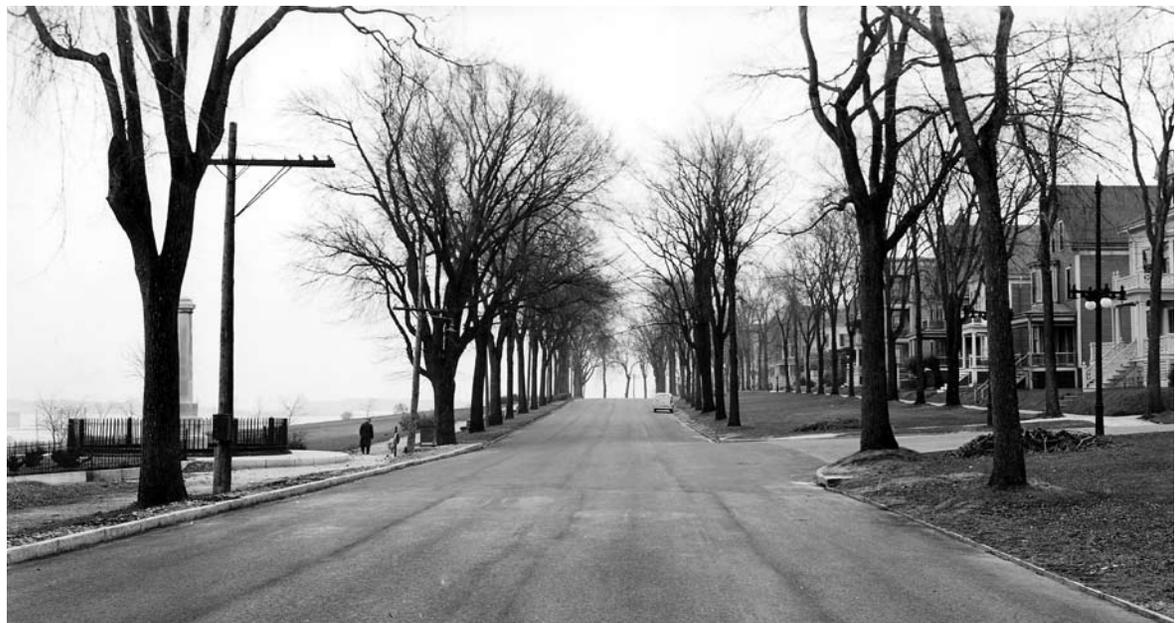
*Eastern Promenade before and after paving, 1937  
[Portland Department of Public Works]*

Cutter Street was widened in 1931. In 1934 it was reported that the bad traffic corner at North Street and the Promenade at the Concourse had been corrected. The Park Commission recommended rebuilding the park roadway with a 36' paved width from Fort Allen to the Northern Concourse. In 1937 Eastern Promenade was paved for the full width of the street. Eastern Promenade is currently 35'-10" wide and Cutter Street is 33'-6" wide.

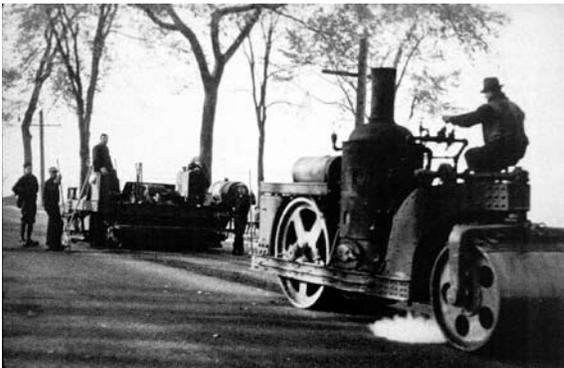
*Eastern Promenade during paving, 1937  
[Portland Department of Public Works]*

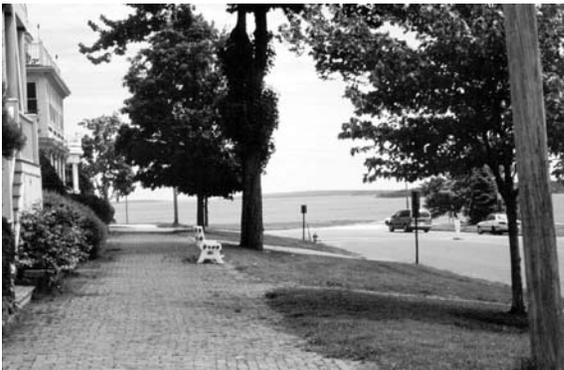
*Wide brick walk at Eastern Promenade, 2003*

Drives are bituminous concrete today. Walk materials on the land side of Eastern Promenade along the esplanade are 6' wide concrete in generally good condition, with occasional stretches of asphalt and brick that are mostly in poor condition. The bituminous concrete walk on the water side of Eastern Promenade is 6' wide and in good condition. There is a 10 to 12' wide brick walk on the land side of Eastern Promenade opposite Fort Allen. This walk is generally in good condition, although there has been some uneven settlement both here and in the narrower 6' wide brick walk connections to the Promenade. Paths in the park are generally 3 to 5' wide bituminous concrete in varying conditions. Desire lines are expressed with bare earth paths at Fort Allen, the Cleeves and Tucker Monument, the Loring Memorial and along the Eastern Promenade drive connection to Washington Street.

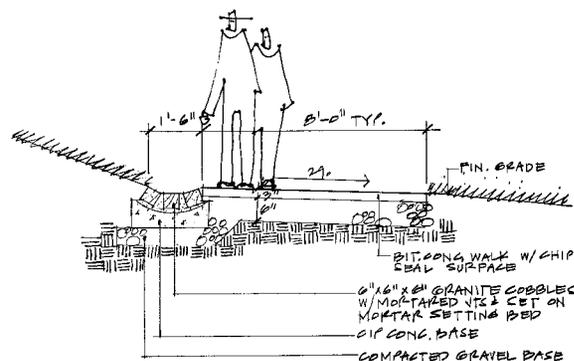
*Rehabilitated pedestrian path with chip seal surfacing and cobblestone gutter in an Olmsted designed park Charlestown Heights, Charlestown MA*

The use of a chip seal material over bituminous concrete is recommended on walks inside the park. This treatment will provide a rustic historic appearance and will reduce the ongoing maintenance requirements associated with gravel or crushed stone. This recommendation is made with the understanding that the city does not plow these walks free of snow because that activity would impair appearance.

Provide cobblestone gutters on the uphill side of walks traversing the slopes of the park to prevent surface drainage from washing over path surfaces. This is a very common Olmsted firm detail used to resolve similar conditions.

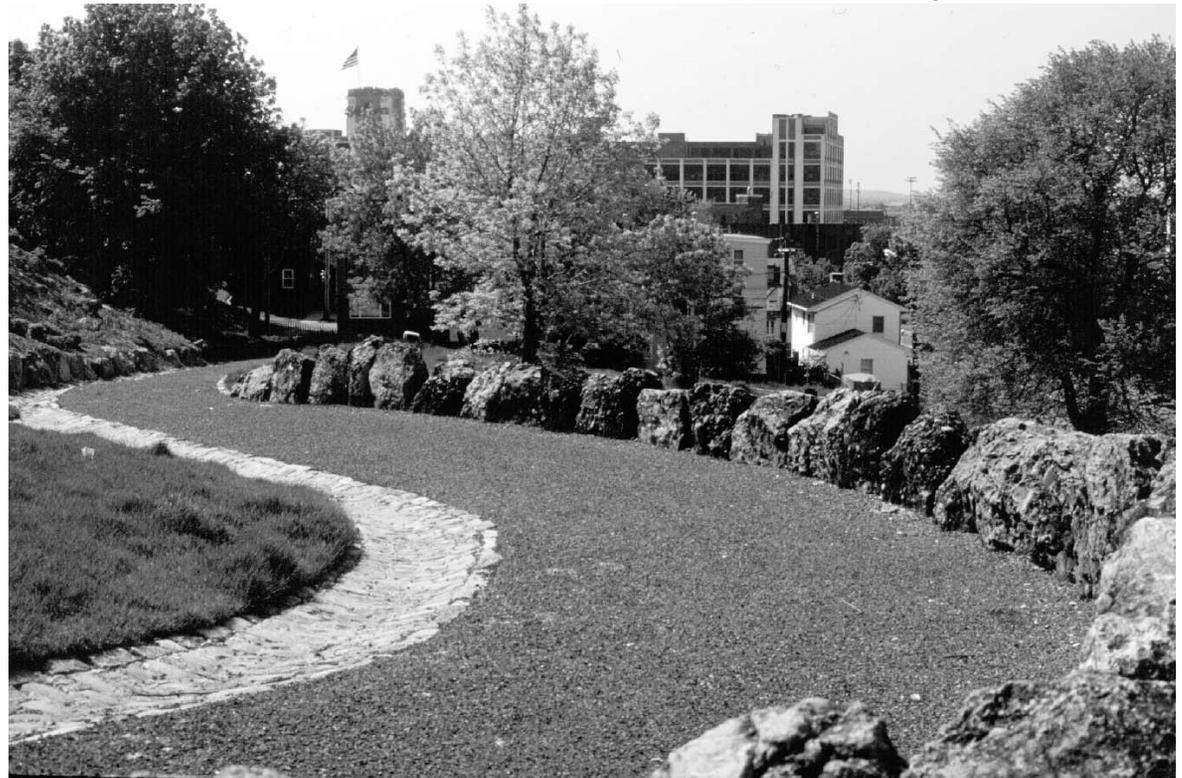
*Proposed path detail on a slope*

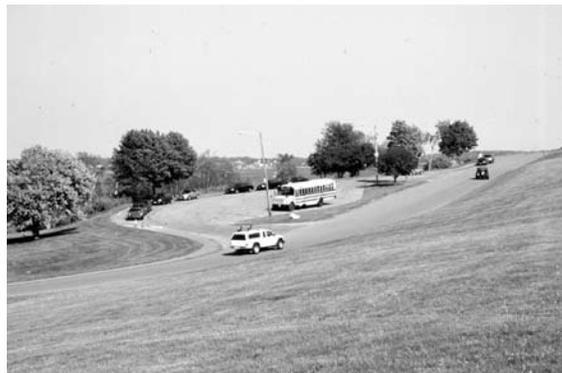
*Cutter Street parking area, 2003*

Parking, both parallel and perpendicular, is allowed on the drive in Fort Allen and on the water side of Cutter Street. Until recently the upper Cutter Street parking area had undefined parking spaces. It now has 6 lined spaces for boat trailers [12' wide, 50' long]. The rest remains undefined. The middle Cutter Street parking area has lined spaces for 9 boat trailers and about 14 regular spaces, some of which have been obstructed by a stockpile of granite curb. This lot also serves as a snow emergency lot during winter and a lay down area for commercial boat ramp activities. The boat launch/beach area has 10 regular spaces, 3 handicap spaces, 13 boat trailer spaces, 1 handicap trailer space, and 2 loading and short-term drop off spaces at the bathhouse.

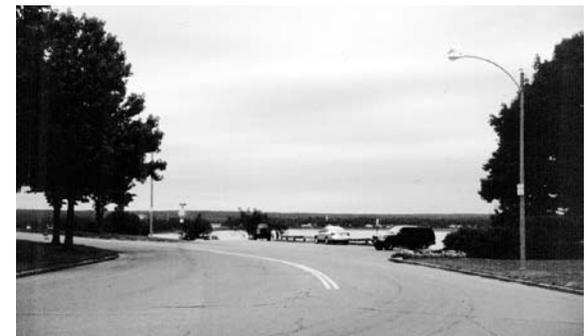
*Eastern Promenade/Cutter Street intersection, 2003*

The above should be done in conjunction with reconstructing the Cutter Street/Eastern Promenade intersection which involves reducing the pavement width and installing a sign prohibiting right turns for commercial vehicles, including vehicles with trailers, from Cutter Street to Eastern Promenade. The Cutter Street exit at Eastern Promenade could also be reconfigured in such a way to help self-enforce the “no truck” ordinance between Cutter Street and the Loring Memorial. The perpendicular parking at the top of Cutter Street should also be eliminated to make the intersection safer.

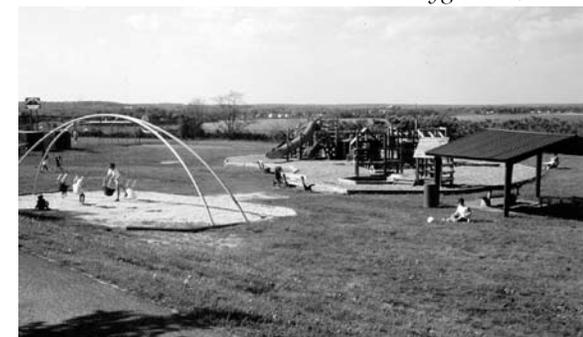
*Wills Playground, 2003*

The playground is in fair condition and well used, but is not handicap accessible internally as well as lacking universal access from the public sidewalk. Raised timber edging surrounding the play equipment and the swings impedes accessibility from surrounding lawn areas. A steep, deteriorating maintenance path into the playground located towards the little league field is blocked off by wood posts with chains. The wood timber play structures with plastic slides are worn, with numerous safety problems like splintering wood, tripping hazards and fall potential due to missing components. Built before today's standards related to safety zones the structure is not in compliance with current requirements. Safety zones are inadequate around the swings as well as in one location at the play structures. The sand surface at the swings is difficult to walk on and is not an acceptable resilient surface. It also has a drainage and ponding problem. One of the steel arch swings is equipped with 4 toddler seats, and the other with 4 strap seats. There are a number of benches in this area including 2 that appear to be missing a matching table at a small shelter, 4 metal benches [2 between the swing sets and 2 along the eastern perimeter], 3 wood benches around the play structure [1 in poor condition that was warped, creating a significant slant to the seat].

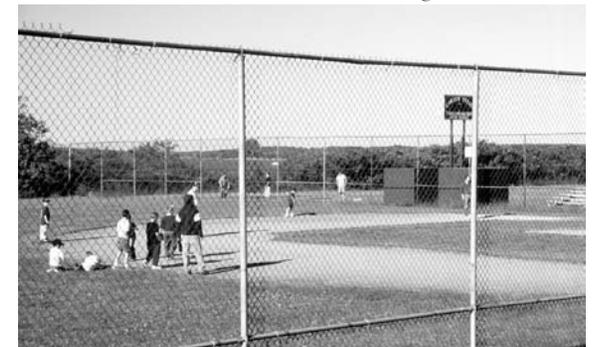
*Carter Little League Field, 2003*

**Carter Little League Field:** This field has a 12' high galvanized steel chain link fence enclosure and backstop that are in fair to poor condition. There are two team benches and one portable bleacher. There are no lights. There is one irrigation head behind the pitchers mound. The field is in poor condition. Surface runoff runs through a dugout. Expressed concerns include the high use of the field and lack of irrigation. Right field does not meet the regulation distance.

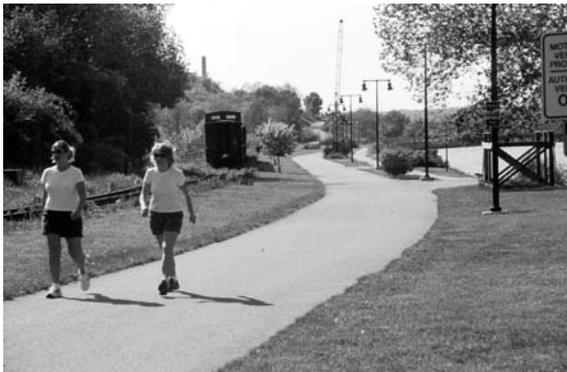
*Eastern Promenade Trail, 2003*

**Eastern Promenade Trail:** After many years of planning, the first phase of the Eastern Promenade Trail was completed in 1997 and has become a great addition and heavily used component of the park. It is in excellent condition. The paved portion is well used, particularly in early evenings on weekdays, while the stonedust portions that separate from the main trail are less used. With an 18' paved width, it is an appropriate multiple use trail. The paved portion is unmarked, presenting a potential hazard for both pedestrian and bicycle users.

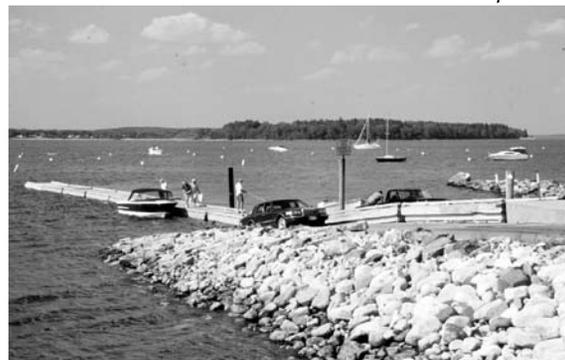
*Recreational Boat Ramp, 2003*

A commercial boat ramp is located near the bathhouse and a public recreational boat ramp is located at the northern end of this small peninsula, near a boat storage area. The commercial ramp is older. The upper area of the ramp is a concrete slab cast on the ground while the lower part going into the water consists of thick precast planks. These planks have large cracks but otherwise are not displaced or out of alignment. It is difficult to see how they were installed but they may have been simply laid on top of the natural rocky shore material. On one side there are large gaps under the planks and on the other side there is unfinished concrete fill against the side of the planks. However, this ramp still seems to be serviceable.

The recreational boat ramp appears to be relatively new and consists of scored precast concrete planks that are bolted together. While this ramp appears to be well built, the bare steel tabs that protrude from notches in the sides of the planks are rapidly corroding, especially where they are alternately washed with seawater on the incoming tide and dried out on the outgoing tide. The 1-1/2" x 1/2" bars appear to be embedded through the width of the concrete plank. That is, the same bar protrudes from both sides of the plank. With the steel expanding as it corrodes, the concrete is starting to crack at the locations of the bars. Eventually, this nicely built ramp will break up from the "rust-jacking" action of the embedded steel. These planks could have lasted for a very long time if the bars had been stainless steel. Galvanized steel would not have worked as well because the protective zinc coating would have been lost rapidly from the corroding effects of the seawater.

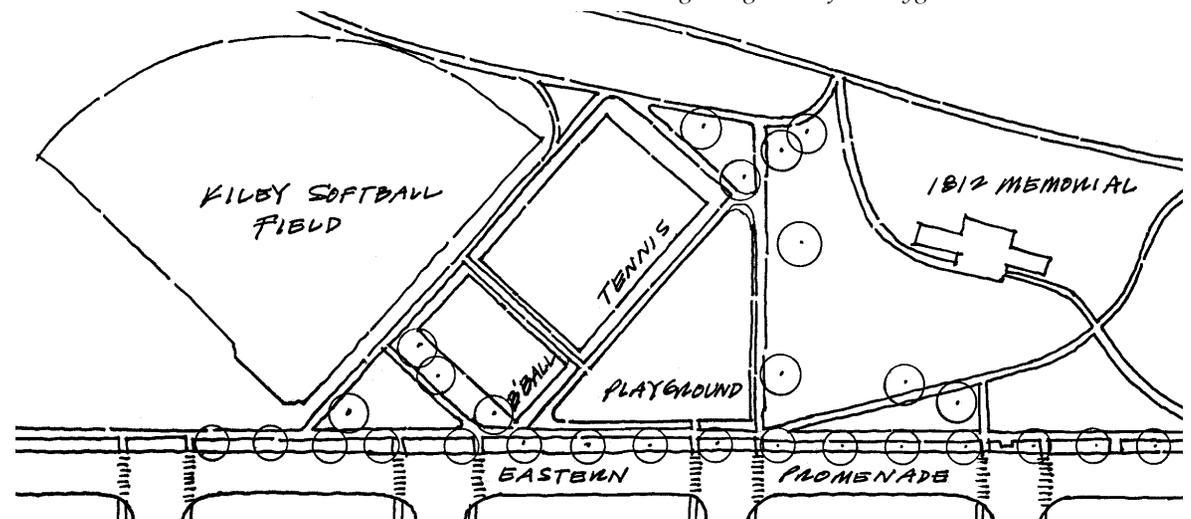
*Long Range Plan for Playground and Hard Courts*

**Playground:** In the long term, replacement of all of the equipment and making the entire facility accessible will be necessary. At that time the playground should be relocated to the area adjacent to the tennis and basketball courts. This should be accomplished in concert with the provision of a new multipurpose field as described in the recommendations for the Carter Little League Field.

**Tennis Courts and Basketball Court:** These facilities are in excellent condition and no immediate recommendations are offered. Given the level of recent investment for these facilities, these uses should be maintained in their current locations as long as they are maintained in good condition and well used. In the long term, relocate these facilities for better use orientation, to reduce the presence of fencing along the promenade and to provide better proximity of the playground to Eastern Promenade as shown in the long range plan for this area.

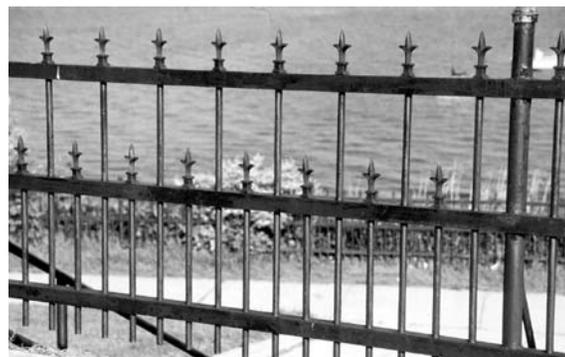
After that the fence was maintained with painting of the lower terrace fence in 1906, painting of all fences in 1910 and repairs in 1923. More wrought iron fence was added in 1933 at which time the granite fence posts were removed. What appears to have been one of the original granite end posts remains today near the bandstand. It supported 3 horizontal rails. The iron fencing was replaced in 1984 with one with a similar design, a decorative black painted steel picket fence with round tubular steel pipe supports and 3 steel angle horizontal rails. The top rail is 31" above the ground, too low for today's safety standards.

The fence is sited at the lower terrace and along the sweeping curve of the walk. The latter is about 640' long and consists of 8' long modules that are connected together at the rails with small welded plates. Each module has one 1-7/8" diameter steel pipe post, 3 rails of 1-3/4" x 1-3/4" x 1/8 or 3/16" angles and 3/4" diameter solid steel pickets spaced 4" apart. The pickets alternate between long ones that connect all 3 rails and short ones that connect only the 2 bottom rails. The tops of the longer pickets are 36" above the ground. All of the pickets are capped with fleur-de-lis finials and the posts are capped with rounded covers. The finials and round covers appear to be production manufactured items. About 50 out of 1,840 finials and 8 of 80 post caps are missing.

At the bottom of each post there is an elongated base shoe that includes a socket for the post and a socket for an 18" long, 3/4" diameter bracing strut. The top of the bracing strut is welded to the post and the base shoe is bolted into an underlying stone or concrete foundation.

The steelwork is in generally good condition although the paint is flaked, cracked and missing throughout the length of the fence. Where the bare steel is exposed, the metal is pitted. The bottom of the fence is hidden in tall growth and in some places vines enclose the entire fence. At some locations where the bottom of the fence can be seen, the posts are corroded through just above the base shoe and the fence can be easily moved in and out.

Because this decorative fence is not a historic fence, it should ultimately be replaced with a fence of appropriate height and picket spacing for today's safety standards. Consideration should be given to replicating the style of the historic decorative iron fence while incorporating current standards. The location of the fence should also be reconsidered when replacement with a taller fence occurs. It would be preferable to locate it in such a position that someone sitting on a bench placed along the adjacent walk would not have to look through the fence to enjoy the view.

Until replacement occurs maintain the fence by thoroughly scraping, cleaning and repainting. Replace missing finials and post caps. Replace corroded posts. To the extent that the bases can be separated from the underlying foundations, it may be easier to take the fence down and restore it in a shop, especially if the existing paint contains lead. The fence modules should be reattached with bolted slip joints.

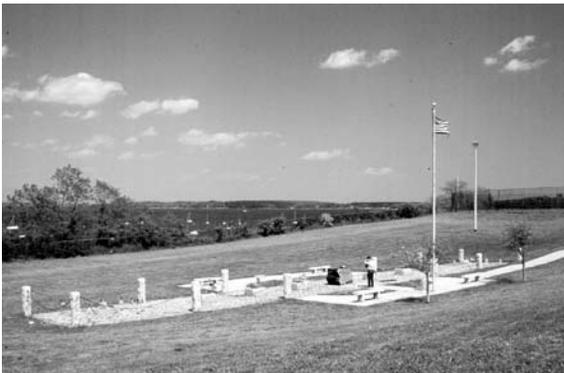
*War of 1812 Burying Ground, 2003*

On Christmas eve in 1812 the British cartel ship *Regulus* arrived in Portland with 230 soldiers captured by the English in the war. 26 men were sick and carried to the hospital on the hill [Fort Allen]. 21 died and were buried here. 5 survived and were later transported to Boston for exchange. In 1876 the 120' long by 12' wide burial ground was described as being "surrounded by an iron fence supported by 6 granite posts, 2 at each end and 2 on either side. Inside the enclosure are 7 Elm trees, 8" to 18" diameter. Grass, no sign, in center is an unchisled granite boulder with an iron tablet". An undated historic photograph reveals that there were actually 8 granite posts.

Renovated in 1986, the iron fence and trees have been removed. It was reported that the fence had been replaced with chain link prior to renovation. The burial ground is now composed of a long rectangular cobblestone surface where individual granite grave markers are set. The ends of the cobble rectangle are enclosed by 12 granite posts with chain. There is a granite boulder and 6 planters inside the enclosure, and a flagpole and 4 backless granite benches outside the enclosure. A bronze plaque mounted on a granite base near the flagpole joins numerous other smaller plaques on the benches and planters. Two small Hawthorns are located outside the enclosure near the flagpole. Aspects of the cemetery treatment are beginning to show signs of age. The wide mortar joints in the cobblestone paving are failing with weed growth present. Some of the chain is rusting, staining the granite.

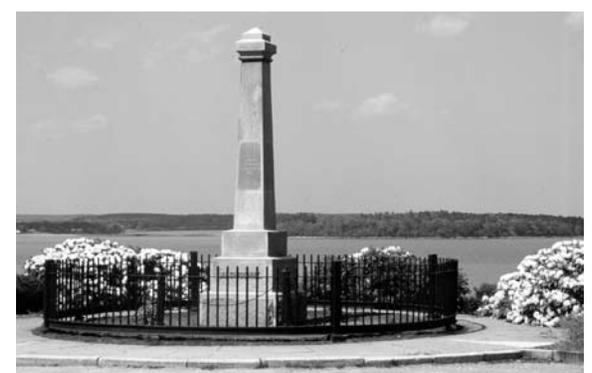
*Cleeves and Tucker Memorial, 2003*

Today a motley of pavement types encircle the monument including grey concrete walks from the street, bituminous concrete from the intersecting sidewalk, and tan concrete surrounding the perimeter of the memorial. The concrete curb prevents universal access to all sides of the memorial. The concrete curb is missing on the water side of the monument. A planted landscape treatment has been added consisting of Catawba Rhododendrons and overgrown yews that are beginning to compete with the scale of the memorial. Although not seen from the street, a large electric control panel has been sited on the water side of the monument.

Encircled by an iron fence, the granite monument from North Jay Quarries has a 6' deep foundation of granite blocks laid in cement. The monument consists of 3 descending tiers of granite blocks topped with a tapered shaft. The stone blocks are set dry and pinned together. There is no mortar between the stones but thin lead shims may have been used to level each tier. The 5' square bottom tier appears to sit on a concrete foundation that is flush with the ground surface. The joint under this unit is fairly large and may have been mortared originally. There is no mortar today and the joint appears to be wet. There is no movement, cracking, staining or botanic growth evident between the tiers.

While the memorial does not require any attention at this time, the space immediately surrounding the memorial does. The concrete curb and plantings should be removed to improve pedestrian access around the memorial and reduce visual competition with it. The Rhododendrons could either be transplanted or replaced in a location separated from the memorial to accommodate this pedestrian space. The lawn inside the fenced perimeter should be replaced with ground cover to ease long term maintenance requirements. Paving around the memorial should be replaced in a manner that is compatible with the high profile of the site that this memorial has been placed on. The large electric control panel should be either relocated to a less prominent location or screened. Provide universal access around the memorial.

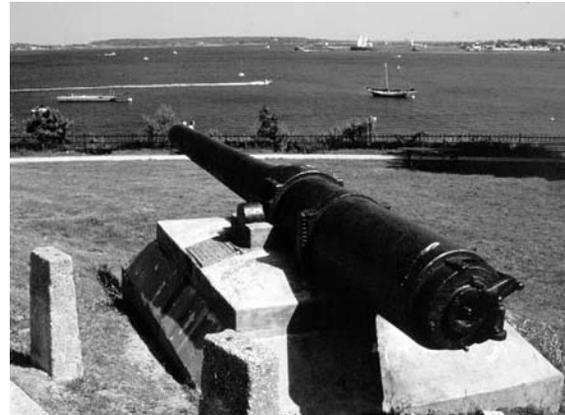
*USS Maine Memorial Cannon , 2003*

A main gun, recovered from the battleship USS Maine that sunk in the harbor of Havana, Cuba on 15 February 1898, was placed in Fort Allen about 1915 on a large concrete foundation. The gun was painted in 1919. It appears that the original foundation has been capped with concrete and a bronze plaque has been added. Edges of the new cap are beginning to exhibit signs of deterioration and the bronze plaque is corroding and staining the concrete.

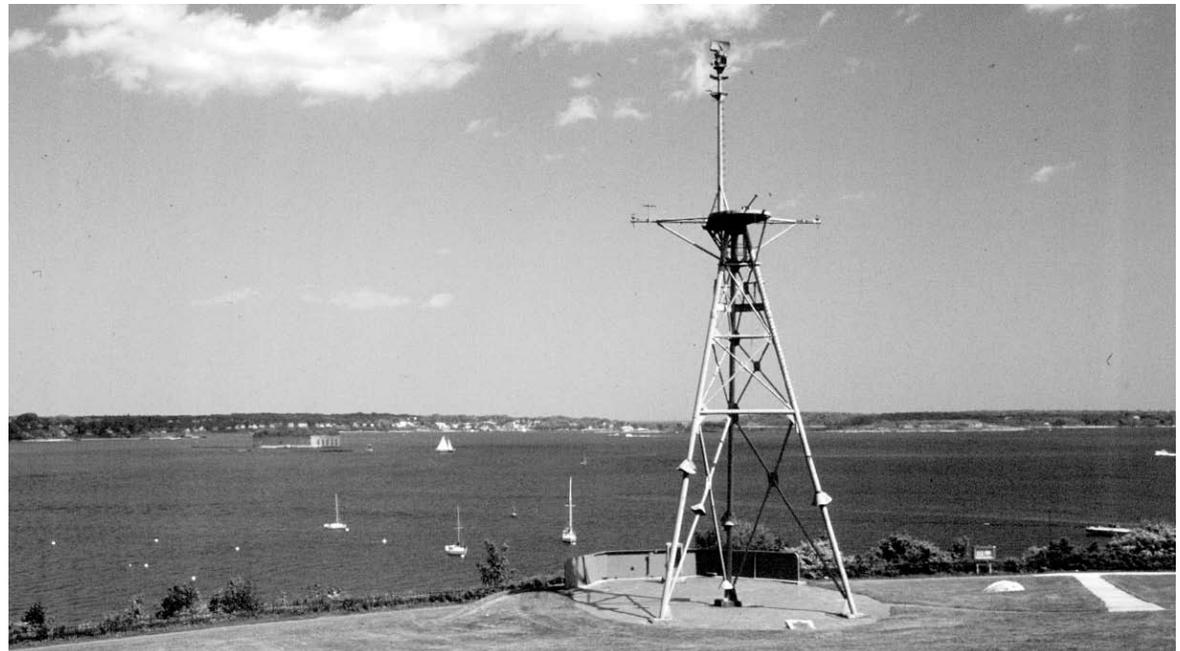
*USS Portland Memorial, 2003*

Facing east, the 51" high navigational bridge shield is a U-shaped section of 1/2" thick steel that is embedded into a concrete foundation. Although the railing and foundation are in good condition, the gray paint is deteriorating and the steel is developing surface rust. The main mast tripod consists of a 3 legged arrangement of steel members that supports the ship's bell and "crows-nest" platforms. The steel is in generally good condition except for a strut near the top that is severely corroded. This condition appears to be very old insofar as a newer strut has been added immediately above the damaged strut. However, the steel is starting to rust where the paint is cracked, blistered and peeling. The paint coating the horizontal steel at the top of the mast is in the worst condition. The main mast tripod has reputedly been struck by lightning on several occasions.

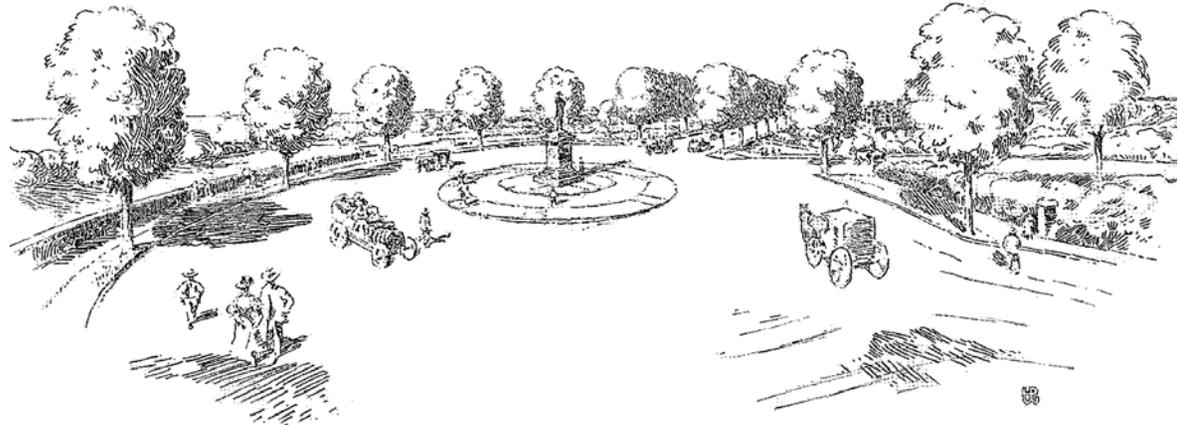
*Olmsted Brothers sketch for the Northern Concourse, 1905  
[National Park Service,  
Frederick Law Olmsted National Historic Site]*

This memorial is located at the Northern Concourse of Eastern Promenade where the Olmsted firm proposed an overlook and monument. Correspondence between Mayor Baxter and the Olmsted firm in the fall of 1905 sheds some light on the considerations for the area. The Mayor initially requested a shelter instead of a monument, but thought that the Olmsted firm would prefer a statue instead. The firm replied that a statue on a monument would be preferable to a shelter. "We fear that in the case of a shelter there would be a sense of disappointment to visitors using it, by not being out on the front of the terrace where they could command a view without the obstruction of carriages and trees and a sense of having a back seat, as it were." The firm then suggested an alternative of a fountain basin with a monumental stone center, but agreed to show a statue on a pedestal.

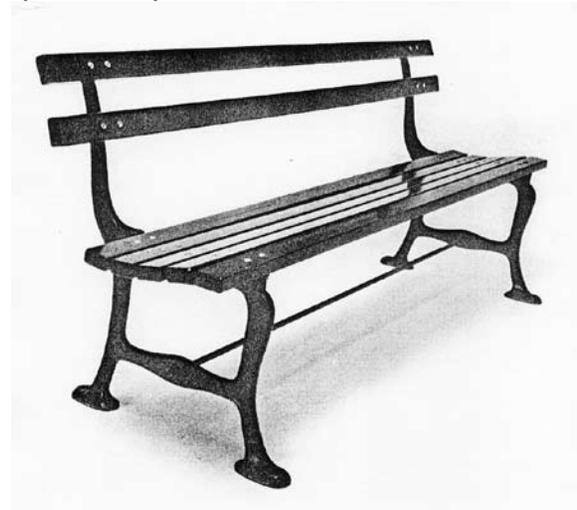
*Bench similar to historic bench  
[No. 6735 Central Park Settee  
by Kenneth Lynch & Sons, Wilton CT]*

The first mention of benches being provided for Eastern Promenade occurred in 1859. More were provided in 1892. The following year seats were to be placed on the terrace of Fort Allen. 20 new seats of a new pattern were placed in Fort Allen in 1901. Additional seats were placed in the addition to Fort Allen in 1905 when it was noted that it had been "a favorite spot for our summer visitors on account of the shade trees" and the seats placed under them. It was noted that although there were seats for over 200 it was not an uncommon sight to see crowds of people lying around on the grass in 1908. More seats were planned for the next summer. A 1937 photograph of Eastern Promenade indicates that benches were constructed of concrete supports with wood seats and backs, like those in that location today.

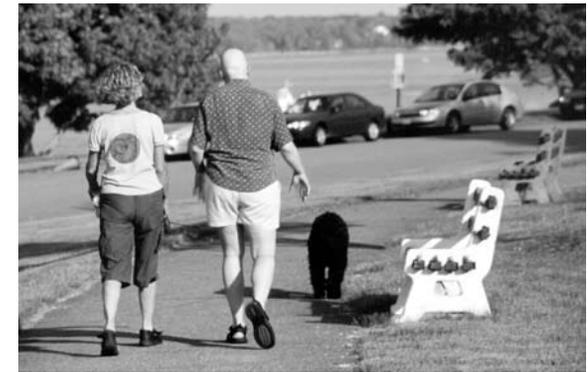
*Bench, 2003*

There appears to be fewer benches in the park overall, and many fewer [6] at Fort Allen than were there in the early 1900s. There are 22 benches in Eastern Promenade today, not counting the 2 near the athletic courts and 7 at the playground. None are the historic model. Most have concrete frames with wood seats and backs, painted light green. There are backless wood benches at the Loring Memorial and the playground has some timber benches as well as wood seats on metal frames. There are also some relatively new backless granite benches in scattered locations around the park, some serving as memorials. Benches set on lawn generally have compacted and eroded earth beneath them.

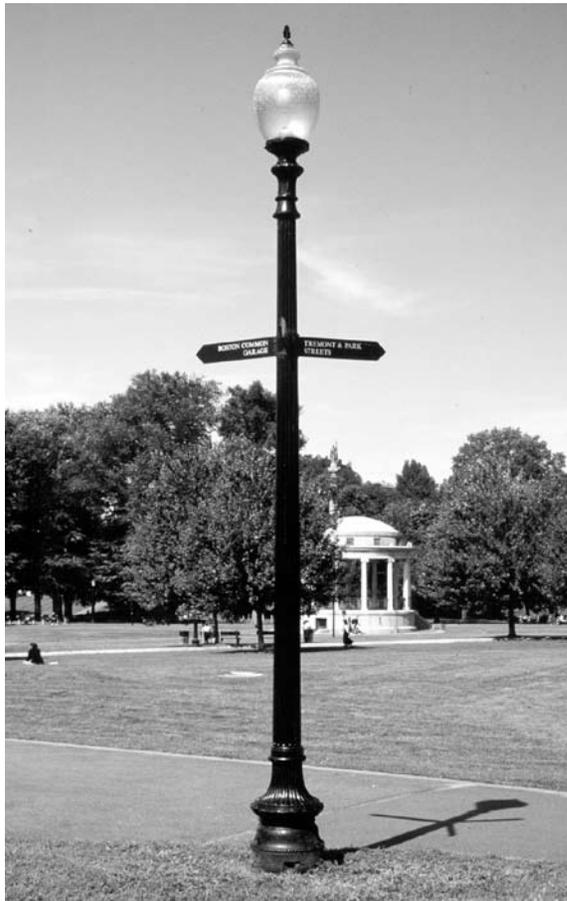
Although it is important not to over sign because they become less effective and create visual clutter, directional signing is often welcome. Directional and orientation signs, including orientation maps, make visitor information easily available. For example, a sign directing visitors to the beach and boat ramp from the top of Cutter Street would be beneficial.

*Directional signs*

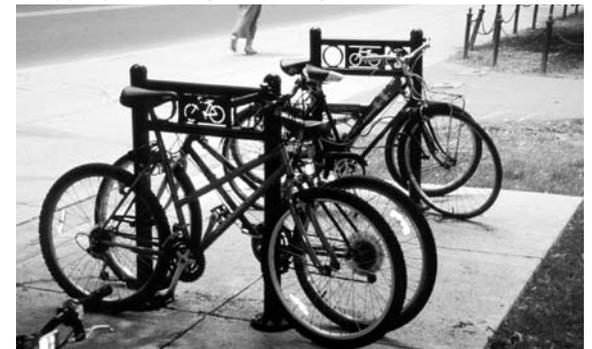
Provide bicycle racks at East End Beach and Fish Point to encourage stops along Eastern Promenade Trail. The style of the racks should be compatible with the light fixtures on the trail.

*Appropriate Bicycle Racks for a historic urban park*

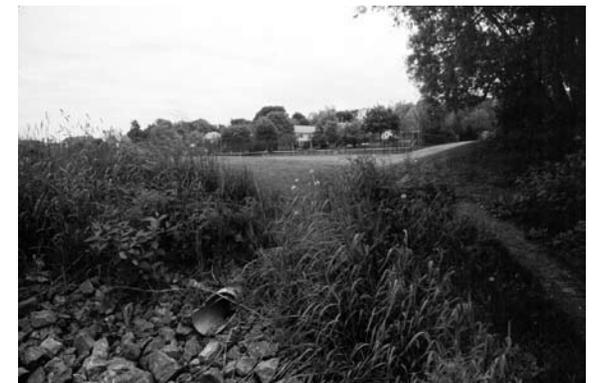
A number of storm drain pipes were found outletting onto the slopes of the park, mostly below Kiley Field and the hard courts.

*Drain outlet below tennis courts, 2003*

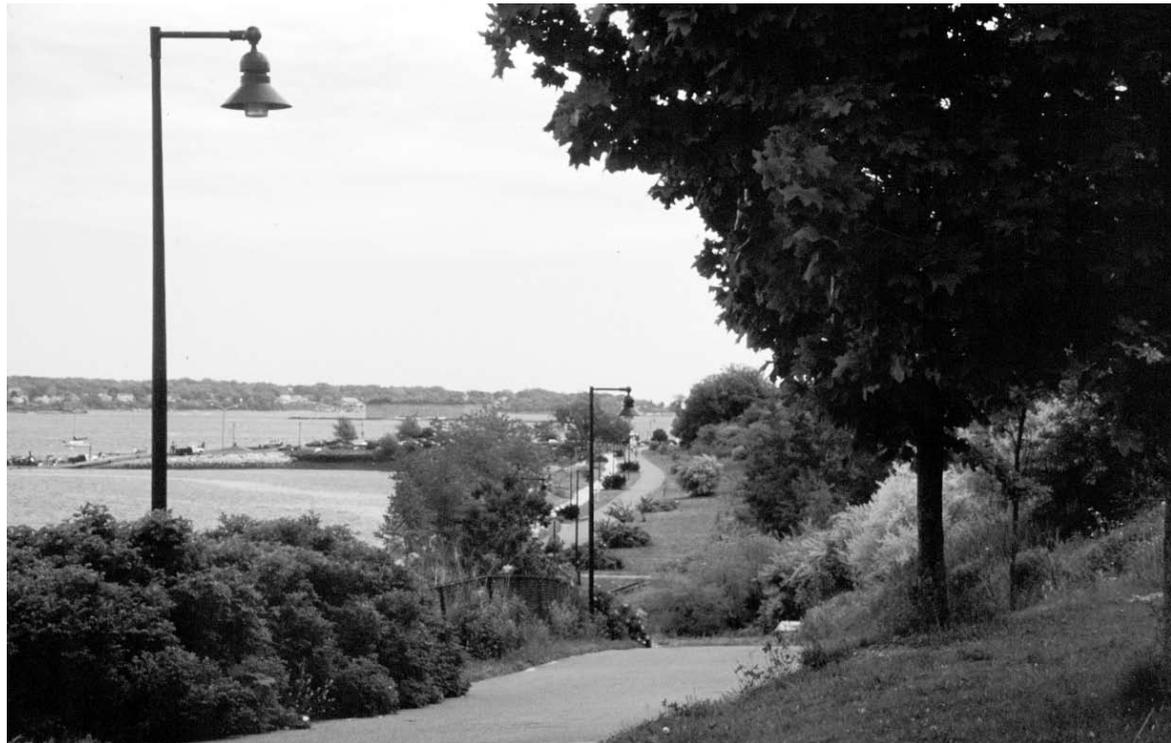
Eastern Promenade Trail has single and double contemporary fixtures mounted from horizontal cross bars on green steel poles. These provide the least light pollution of the fixtures in the park as the illumination is directed downward towards the path. The Loring Memorial is illuminated entirely with uplights. There is a pole mounted floodlight illuminating the 1812 burial ground. Not operating, it was recently removed from the pole. There are also security lights at the bandstand and bathhouse.

*Light fixture on Eastern Promenade Trail, 2003*

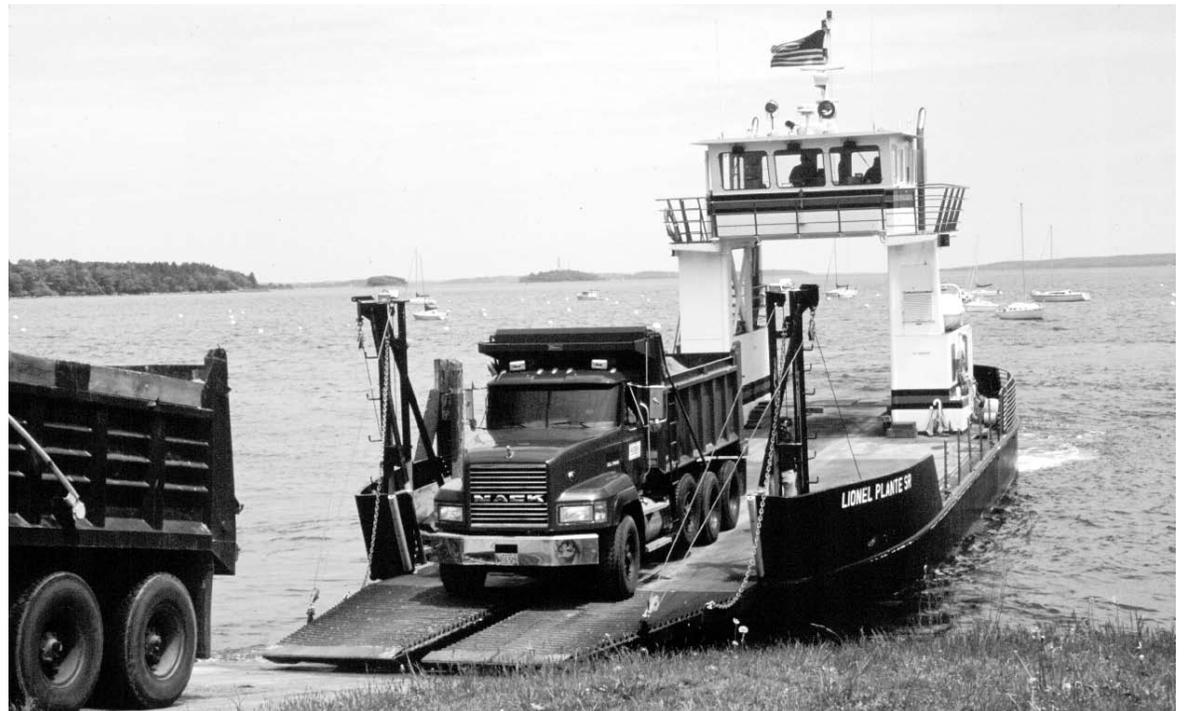
*Commercial boat ramp in operation, 2003*

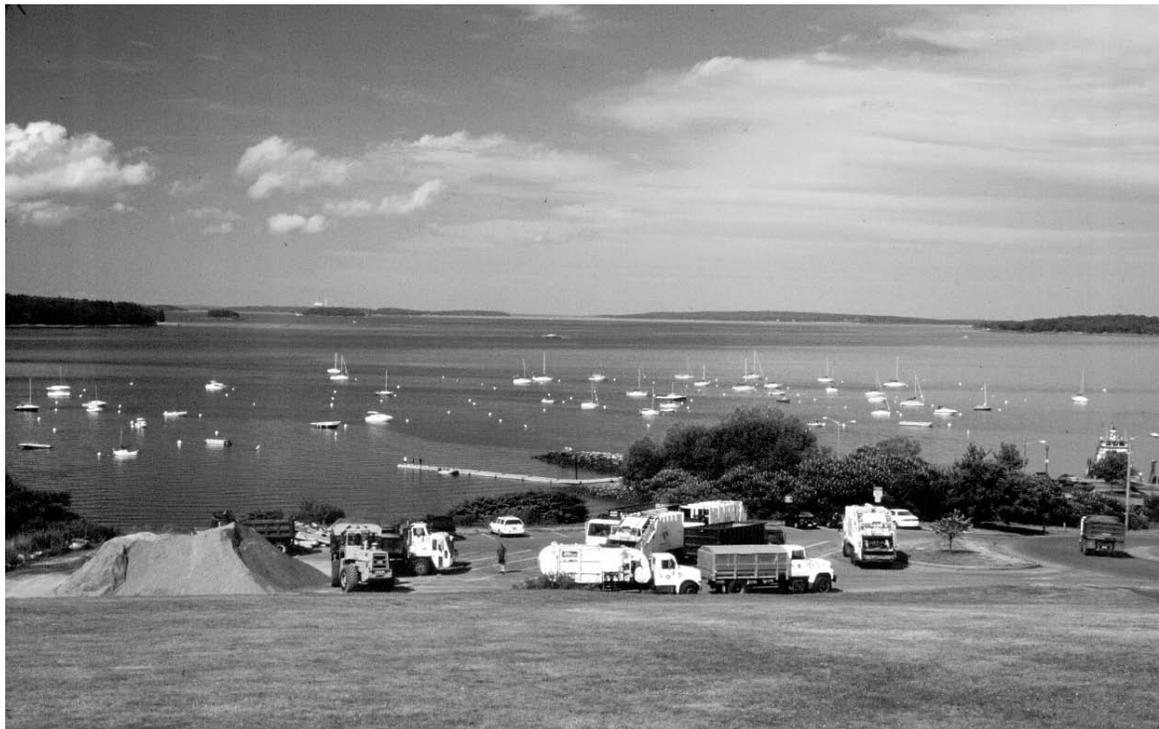
*Staging area in operation, 2003*
